# Complete Engineering Inspection Case Study

Full anonymized public edition compiled from both submitted reports

ENGINEERING EXECUTIVE SUMMARY

Overall Engineering Condition Assessment

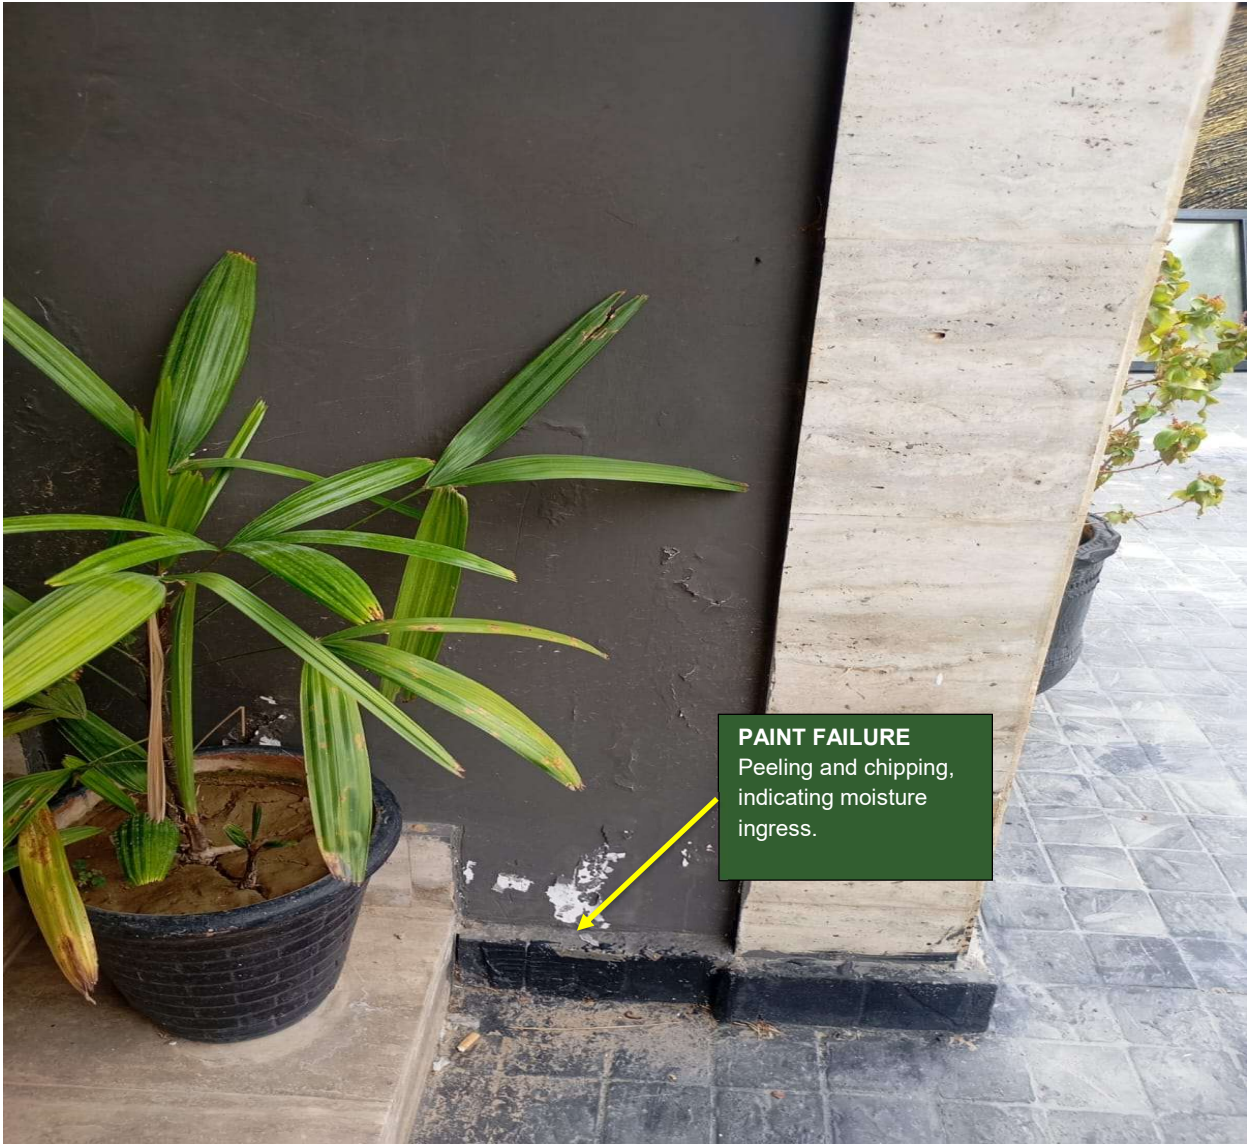
ISSUE 1Moisture Damage Resulting in Exterior Paint Failure

Paint failure (peeling and chipping) was observed near the main entrance steps, indicating moisture ingress behind the painted surface.

| ENGINEERING ASSESSMENT<br>The observed paint failure is indicative of moisture ingress behind the coating system, resulting in loss of adhesion and localized paint delamination. If the underlying source of moisture is not identified and rectified, the deterioration is likely to recur and may lead to progressive damage to the plaster/render. | | | |

| RECOMMENDED ACTION | Chip off all damaged paint, treat the affected area with a moisture-resistant waterproofing chemical after addressing the source of moisture, apply primer, and repaint with an exterior-grade weather-resistant paint. | | |

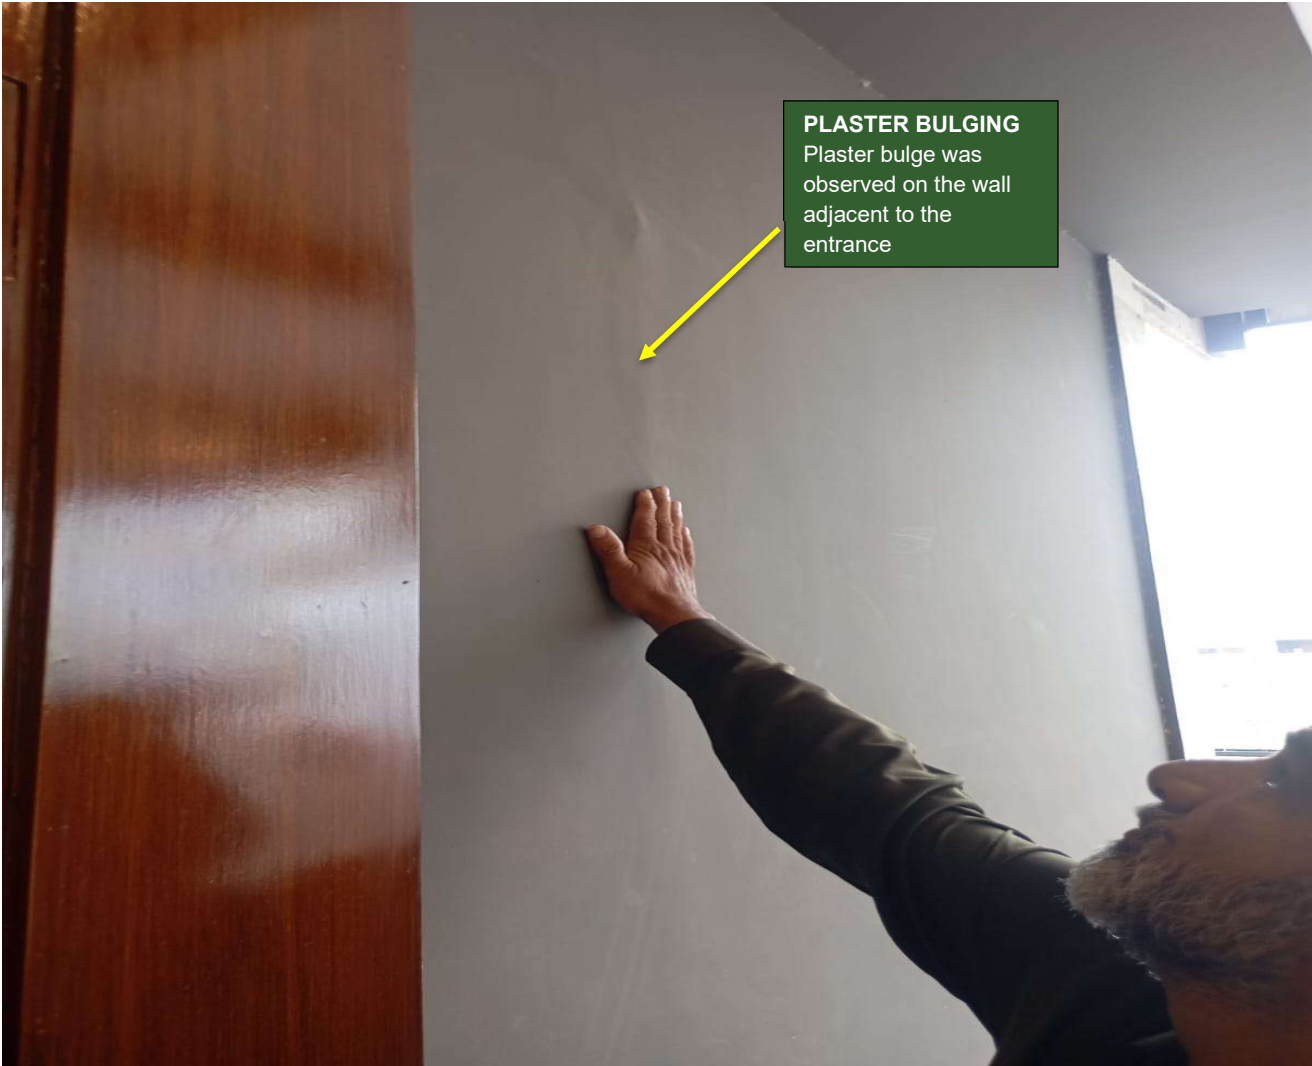
Localized Plaster Bulging (Surface Delamination)

A localized plaster bulge was observed on the wall adjacent to the entrance. The affected area is raised from the surrounding surface, indicating partial debonding of the plaster from the underlying substrate.

| ENGINEERING ASSESSMENT<br>The observed plaster bulging is indicative of localized plaster delamination, most likely resulting from inadequate substrate preparation, insufficient bonding during plaster application, or moisture ingress. If left unattended, the affected area may continue to expand and eventually detach, posing a safety hazard and leading to further deterioration of the wall finish. Timely remedial works are recommended to restore the integrity and durability of the wall finish | | | |

| RECOMMENDED ACTION | Remove the loose and delaminated plaster up to the sound substrate, inspect for any underlying moisture or bonding deficiencies, carry out necessary substrate repairs, reapply plaster using the specified mortar mix with a suitable bonding agent, allow proper curing, and finish with primer and paint to match the existing surface. | | |

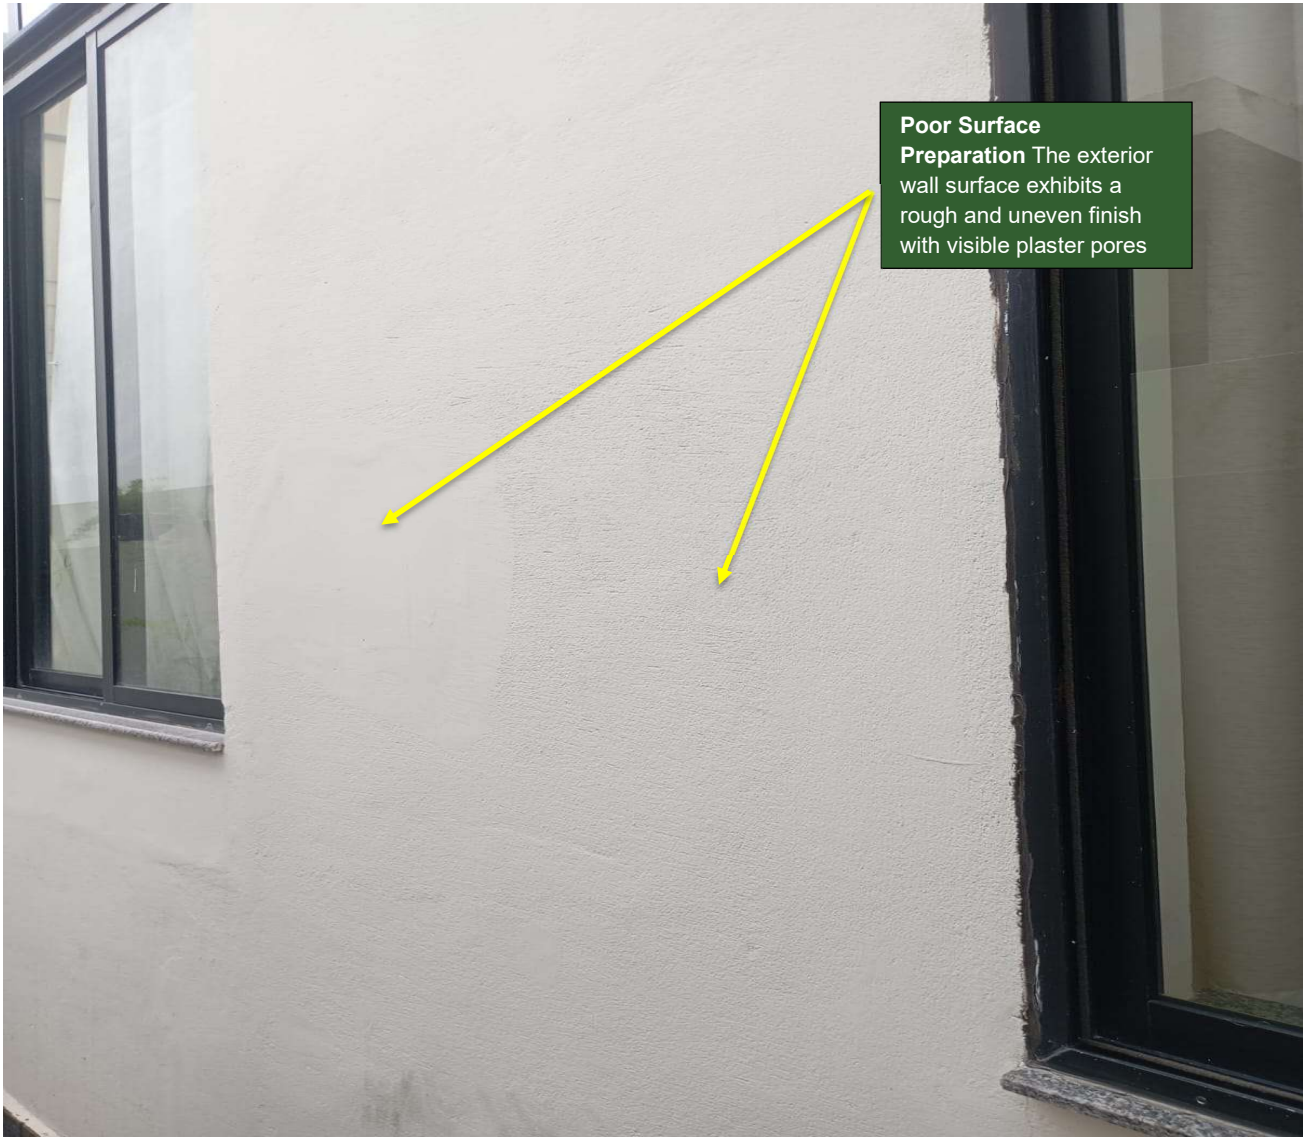
Poor Surface Preparation Resulting in Visible Plaster Pores

The exterior wall surface exhibits a rough and uneven finish with visible plaster pores and surface imperfections. The substrate was not adequately prepared, and pour filling/skim coating was insufficient prior to the application of the paint system, resulting in a poor aesthetic finish.

| The observed defect is primarily a workmanship and quality control issue arising from inadequate surface preparation before painting. Although the defect does not currently affect the structural integrity of the wall, it compromises the appearance and long-term performance of the paint system. Proper surface rectification and refinishing are recommended to achieve a durable, uniform, and aesthetically acceptable façade finish. | | | |

| RECOMMENDED ACTION | Mechanically sand the affected surface and apply a suitable exterior-grade wall putty or skim coat to fill all plaster pores and surface irregularities. After achieving a smooth finish, apply the recommended primer followed by two coats of high-quality exterior weather-resistant paint in accordance with the manufacturer's specifications. | | |

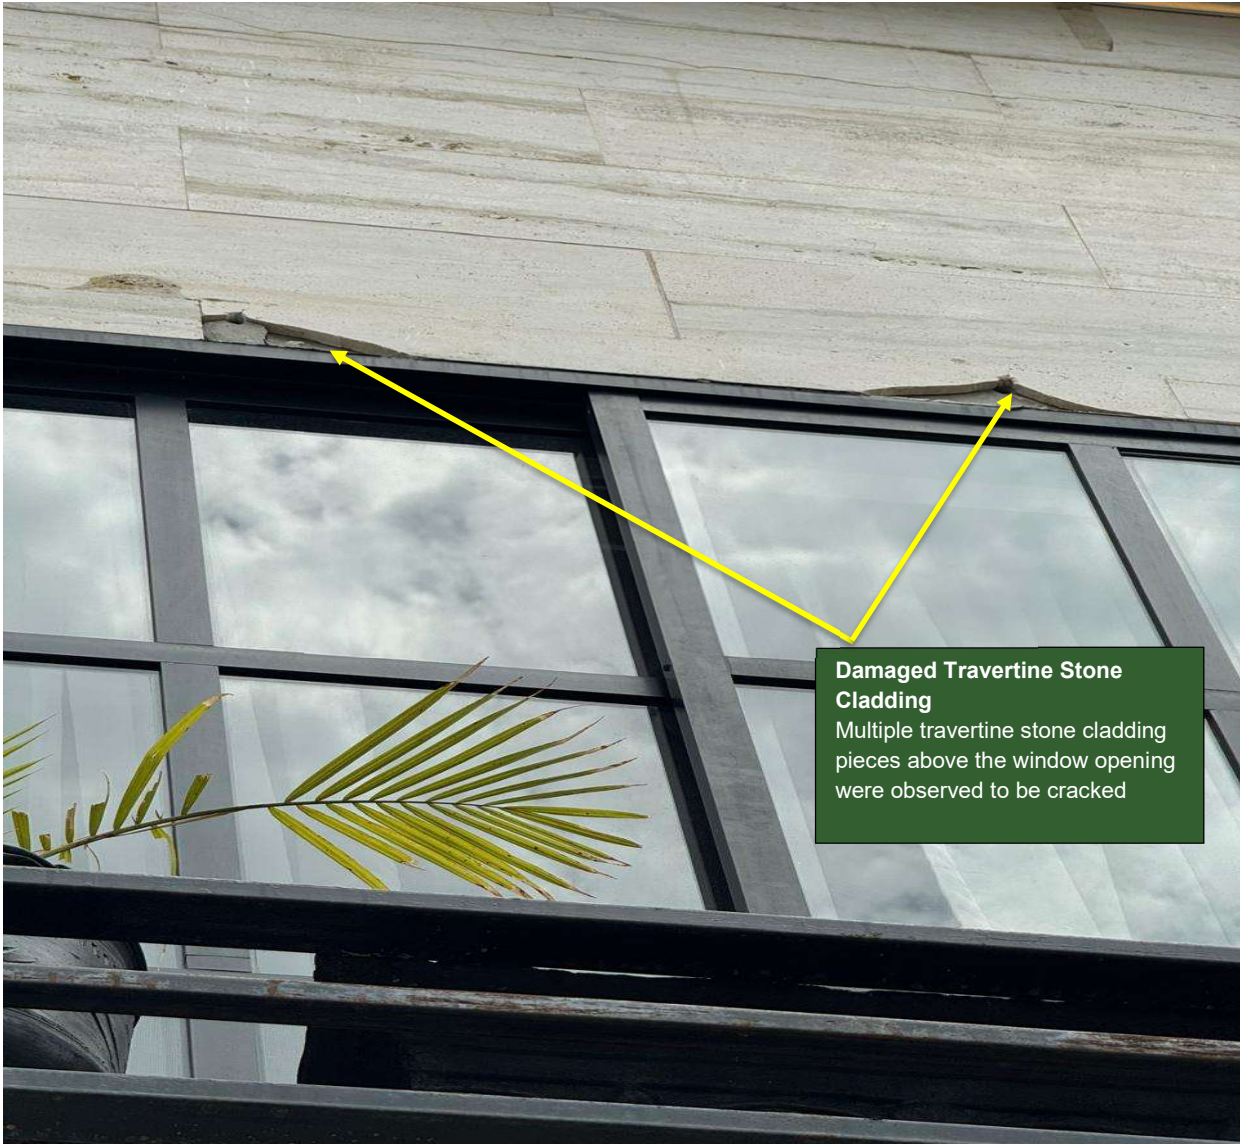
Damaged and Detached Travertine Stone Cladding

Multiple travertine stone cladding pieces above the window opening were observed to be cracked, broken, and partially detached from the façade, creating an uneven finish and a potential falling hazard.

| ENGINEERING ASSESSMENT<br>The damaged travertine cladding indicates failure of the stone fixing system and/or deterioration due to inadequate bonding, installation defects, or environmental exposure. As the affected stones are located at an elevated level, there is a risk of further detachment, which poses a safety hazard to occupants and visitors. Immediate replacement of the damaged cladding and verification of the stability of adjacent stone panels are recommended to ensure the long-term safety and durability of the façade. | | | |

| RECOMMENDED ACTION | Carefully remove all loose and damaged travertine pieces, inspect the substrate and fixing system for deficiencies, and replace the affected stones with matching travertine using an approved exterior-grade stone adhesive or mechanical anchoring system as required. Ensure proper joint treatment and alignment with the existing façade. | | |

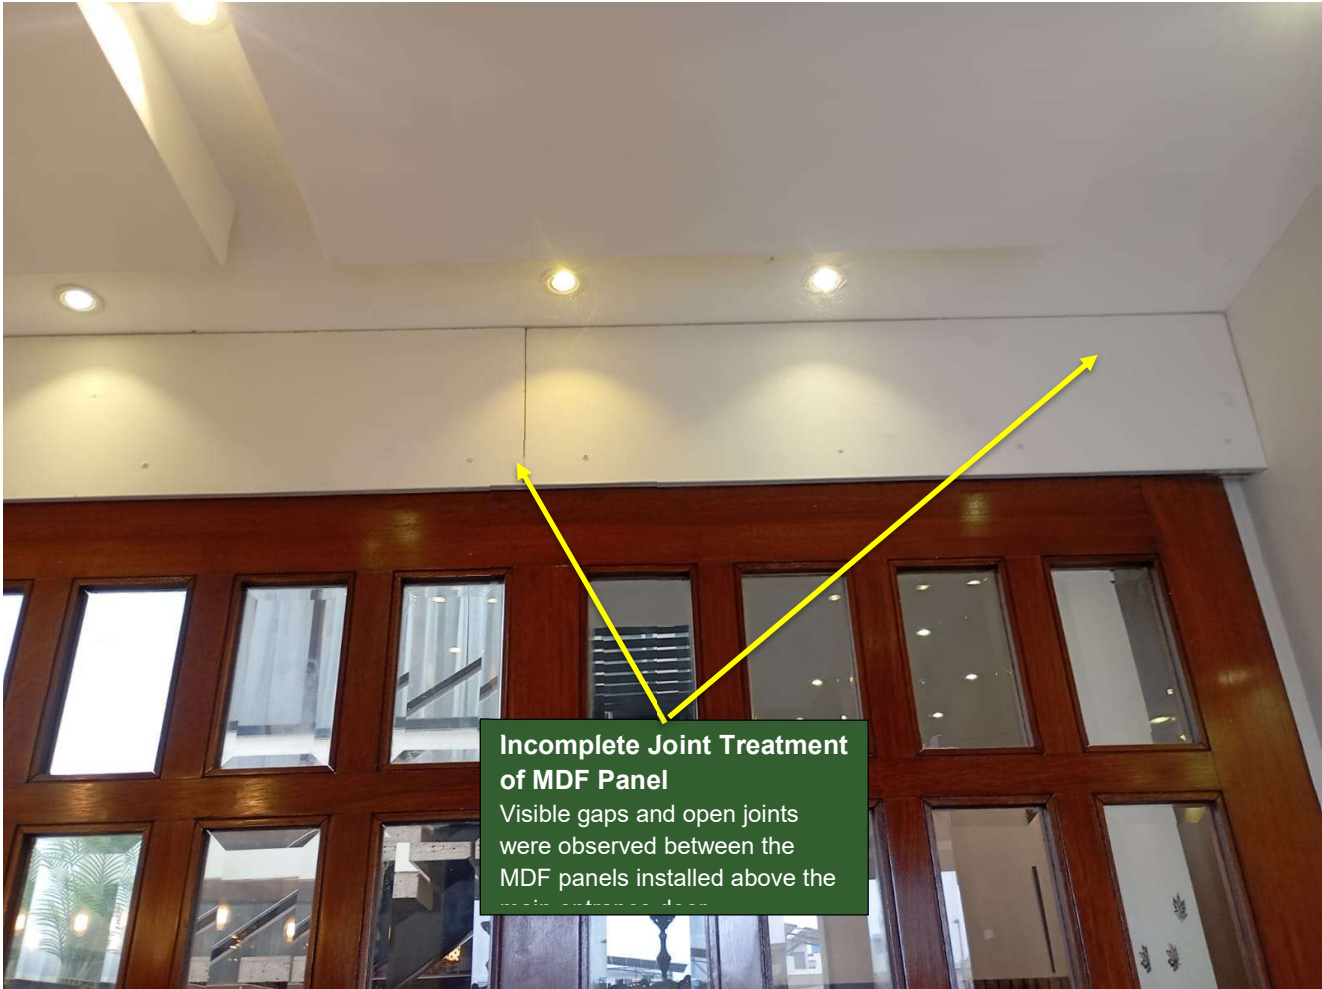
ISSUE 5Incomplete Joint Treatment of MDF Panel Above Main Entrance Door

Visible gaps and open joints were observed between the MDF panels installed above the main entrance door. The panel joints have not been properly filled, finished, or sanded prior to painting, resulting in a noticeable discontinuity in the surface finish.

| ENGINEERING ASSESSMENT<br>The observed defect is a workmanship and finishing quality issue resulting from inadequate joint treatment during MDF panel installation. While the defect does not currently affect the structural performance of the panel, untreated joints are susceptible to cracking due to thermal movement and humidity variations, leading to progressive deterioration of the finished surface. Proper joint treatment and refinishing are recommended to achieve a durable, crack-free, and aesthetically acceptable finish. | | | |

| RECOMMENDED ACTION | Clean the joints and fill all gaps using a suitable MDF joint filler or wood filler. Reinforce joints with joint tape where required, sand the surface to achieve a flush and seamless finish, apply primer, and repaint the entire panel to ensure a uniform appearance. | | |

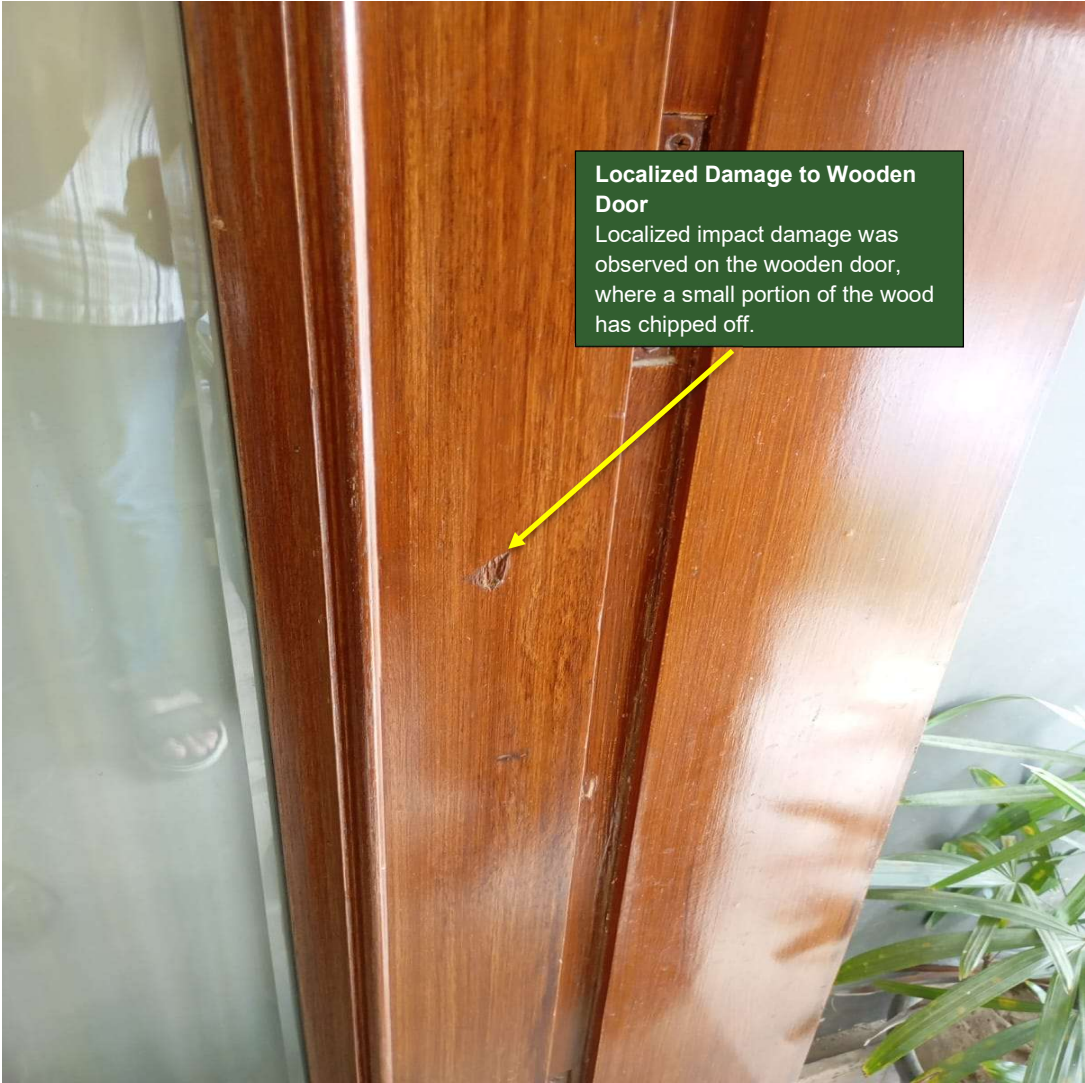
Localized Damage to Wooden Door

A localized impact damage was observed on the wooden door, where a small portion of the wood has chipped off, exposing the underlying substrate and affecting the overall appearance of the finished surface.

| ENGINEERING ASSESSMENT<br>The observed defect is a localized physical damage caused by impact during handling or use. While it does not currently affect the structural integrity or functionality of the door frame, the exposed surface is vulnerable to moisture ingress, further deterioration, and degradation of the finish. Prompt repair is recommended to restore the aesthetic quality and protect the timber from future damage. | | | |

| RECOMMENDED ACTION | Remove any loose wood fibers, fill the damaged area with a suitable wood filler or epoxy wood repair compound, sand the repaired surface smooth, and refinish the area with a matching wood stain and protective clear coat to restore the original appearance. | | |

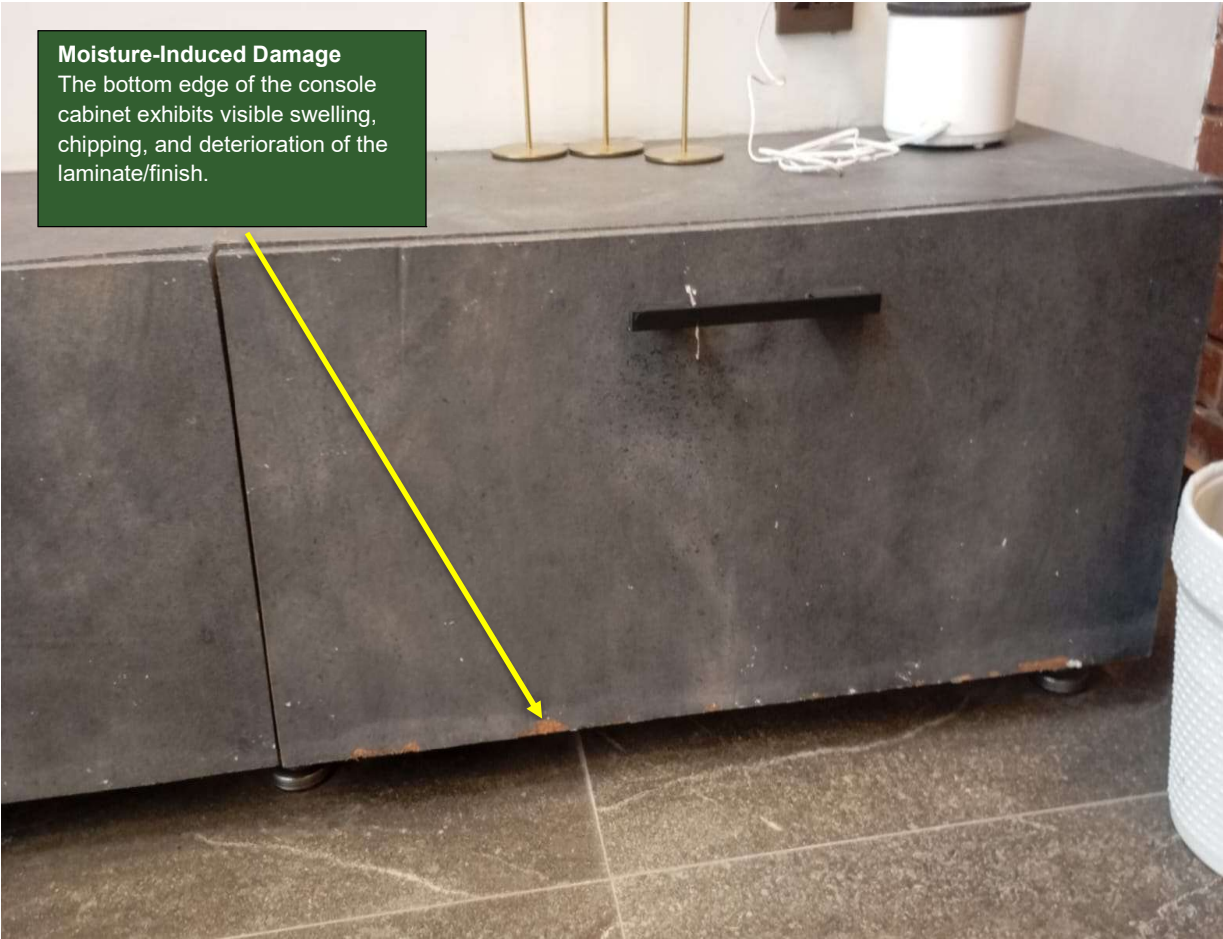
ISSUE 7Moisture-Induced Damage to Base of Console Cabinet

The bottom edge of the console cabinet exhibits visible swelling, chipping, and deterioration of the laminate/finish. The damage is concentrated along the lower edge, indicating prolonged exposure to moisture, most likely resulting from water contact during routine floor cleaning.

| The observed deterioration is consistent with moisture absorption by the engineered wood substrate, leading to swelling and delamination of the laminate finish. Although the damage is primarily cosmetic at this stage, continued exposure to water will accelerate material degradation, reduce the service life of the cabinet, and may eventually compromise its structural integrity. | | | |

| RECOMMENDED ACTION | Replace the damaged console cabinet bottom panel with a new panel of matching material, finish, and dimensions. Ensure all exposed edges are properly sealed with a moisture-resistant edge banding or sealant, and provide adequate clearance or a protective plinth at the base to prevent future water damage during floor cleaning. | | |

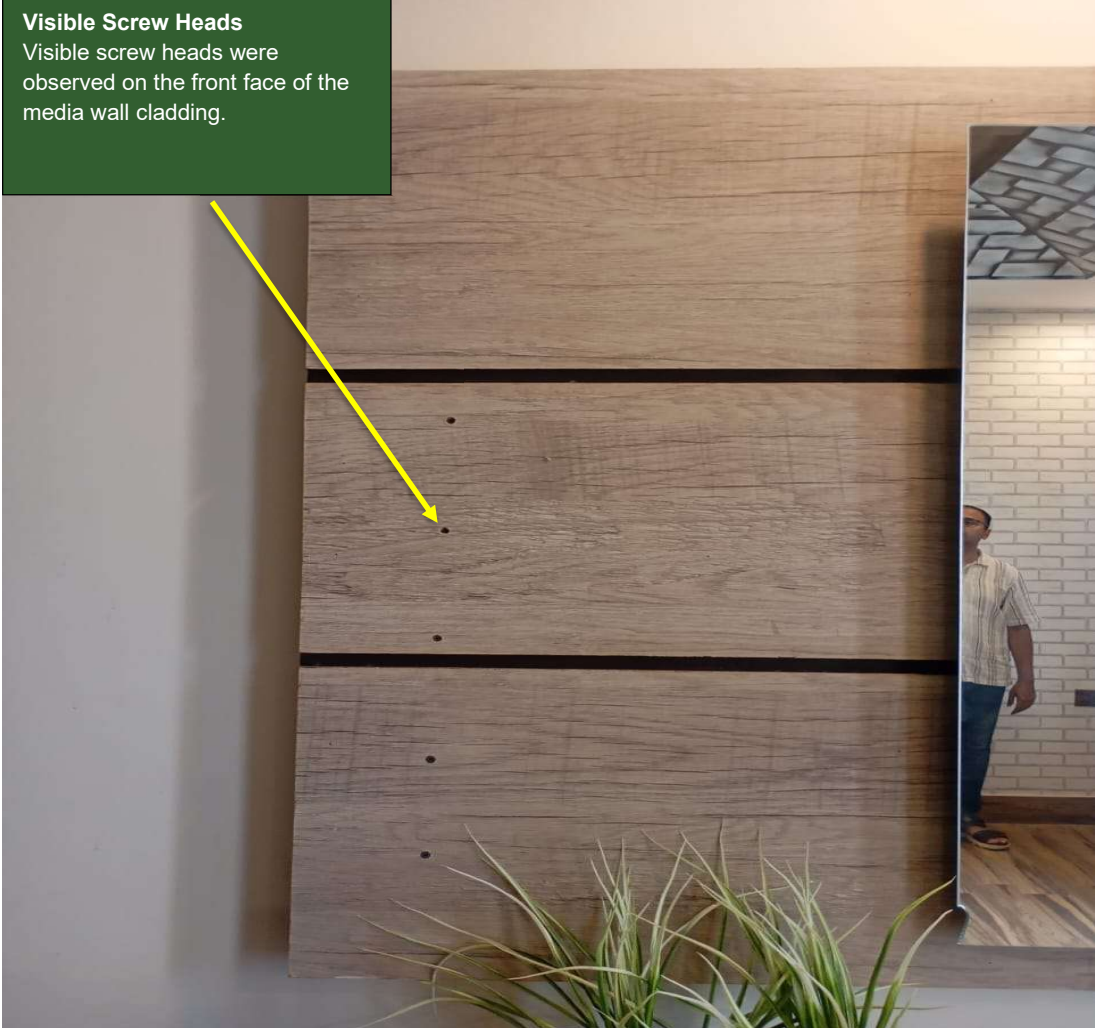
ISSUE 8Visible Screw Heads on Media Wall Cladding

Visible screw heads were observed on the front face of the media wall cladding. The exposed fasteners detract from the intended seamless appearance of the finished panel and indicate poor finishing workmanship.

| ENGINEERING ASSESSMENT<br>The observed defect is an aesthetic and workmanship issue rather than a structural deficiency. Although the visible screw heads do not affect the stability or performance of the media wall, they do not meet the expected finish quality for premium interior joinery. Concealed fixing and proper surface finishing are recommended to achieve the required architectural standard and visual appearance. | | | |

| RECOMMENDED ACTION | Replace all affected media wall panels exhibiting exposed screw heads with new panels installed using a concealed fixing system. All visible fasteners shall be eliminated by using headless (brad) nails or concealed fixings to achieve a seamless, high-quality finish in accordance with the approved design and workmanship standards. | | |

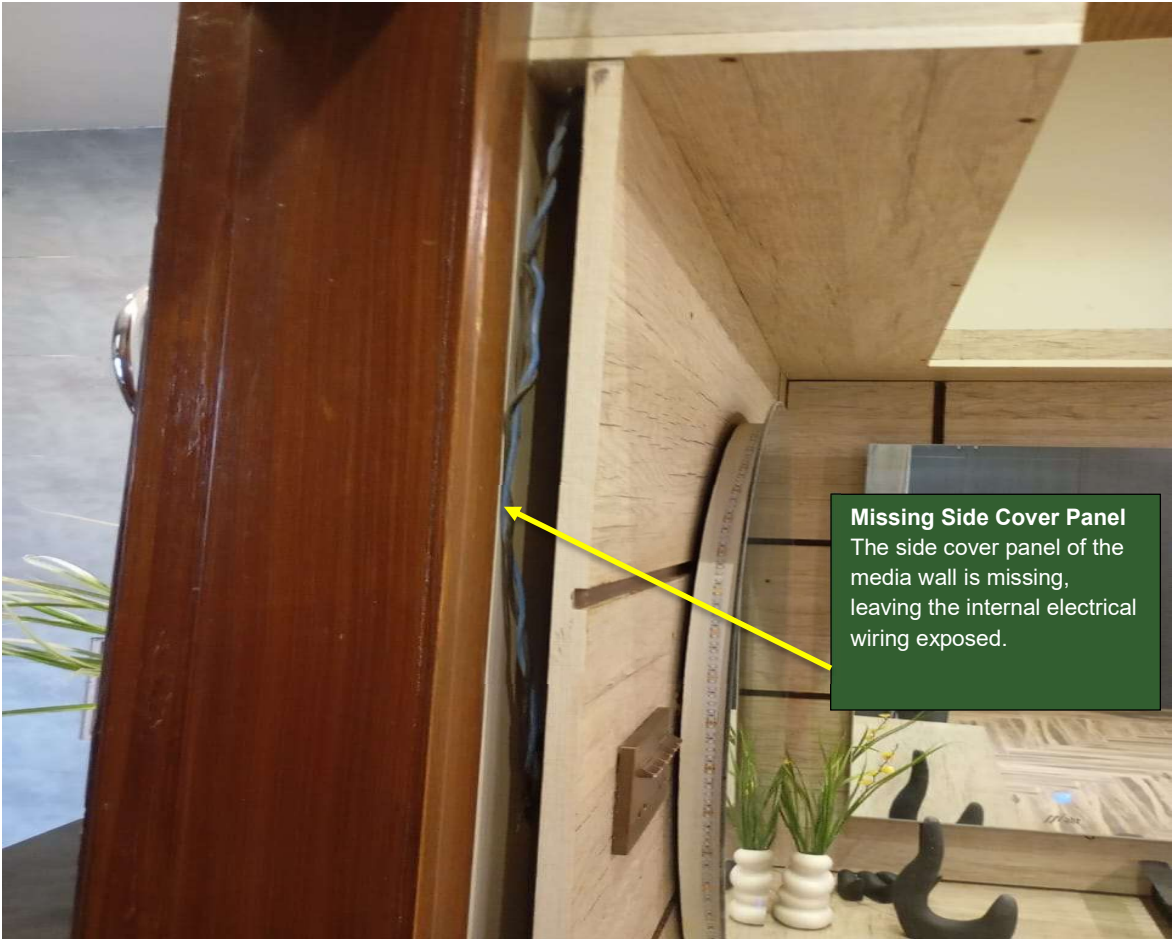
ISSUE 9Missing Side Cover Panel Exposing Electrical Wiring

The side cover/packing panel of the media wall is missing, leaving the internal electrical wiring exposed. The unfinished side edge adversely affects the overall appearance and exposes the wiring to accidental damage.

| The observed defect is primarily a workmanship and finishing issue. While the exposed wiring does not currently indicate an electrical fault, leaving cables visible reduces the aesthetic quality of the installation and increases the risk of accidental damage to the wiring. Installation of the missing side panel is recommended to achieve a safe, neat, and architecturally acceptable finish. | | | |

| RECOMMENDED ACTION | Install the missing side cover panel using material, finish, and dimensions matching the existing media wall. Ensure all electrical wiring is properly concealed and secured within the panel, maintaining adequate access for future maintenance where required. | | |

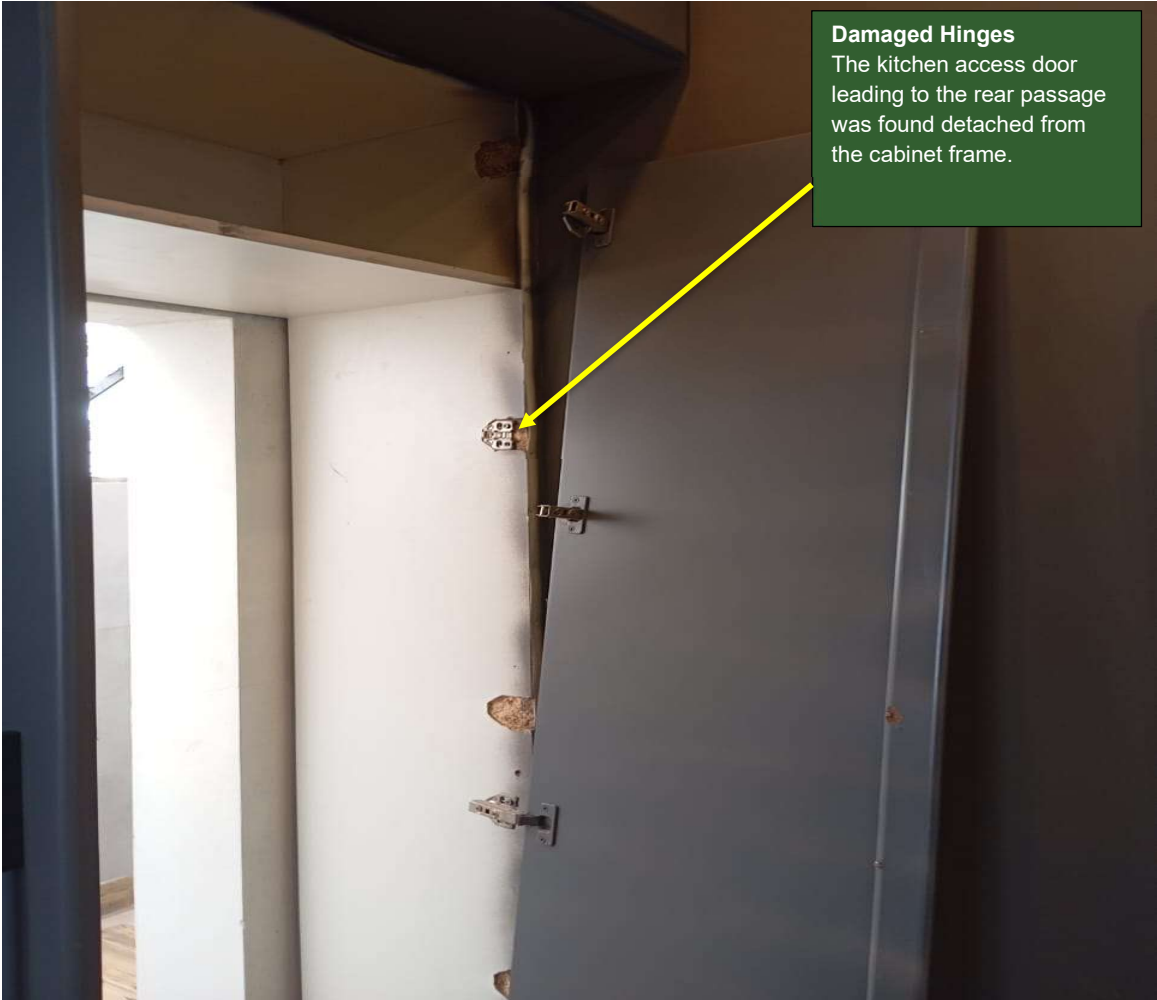
ISSUE 10Kitchen Access Door Detached Due to Damaged Hinges

The kitchen access door leading to the rear passage was found detached from the cabinet frame. The door hinges are damaged, preventing the door from being securely mounted and operated.

| The observed defect is a functional failure resulting from damaged cabinet hardware. Although it does not affect the structural integrity of the cabinet, the detached door compromises usability, safety, and the overall finish quality of the kitchen joinery. Replacement of the damaged hinges and proper reinstallation of the door leaf are recommended to restore the intended functionality and appearance. | | | |

| RECOMMENDED ACTION | Replace all damaged hinges with new heavy-duty concealed cabinet hinges of the specified type, reinstall and properly align the door leaf, and adjust the hinges to ensure smooth operation, correct clearances, and proper closing. | | |

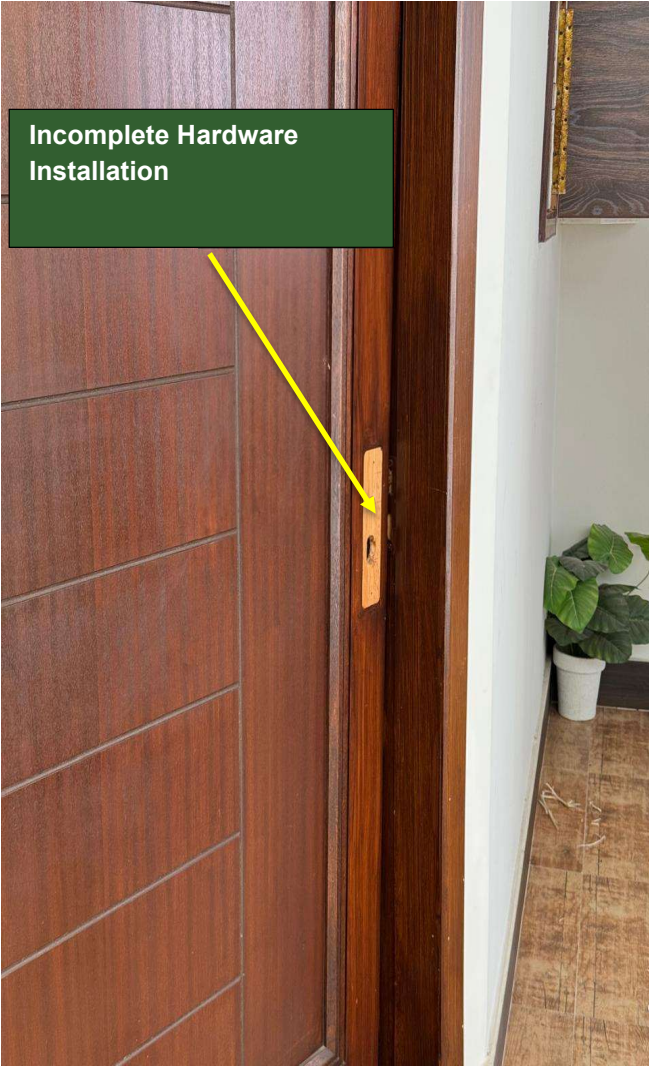
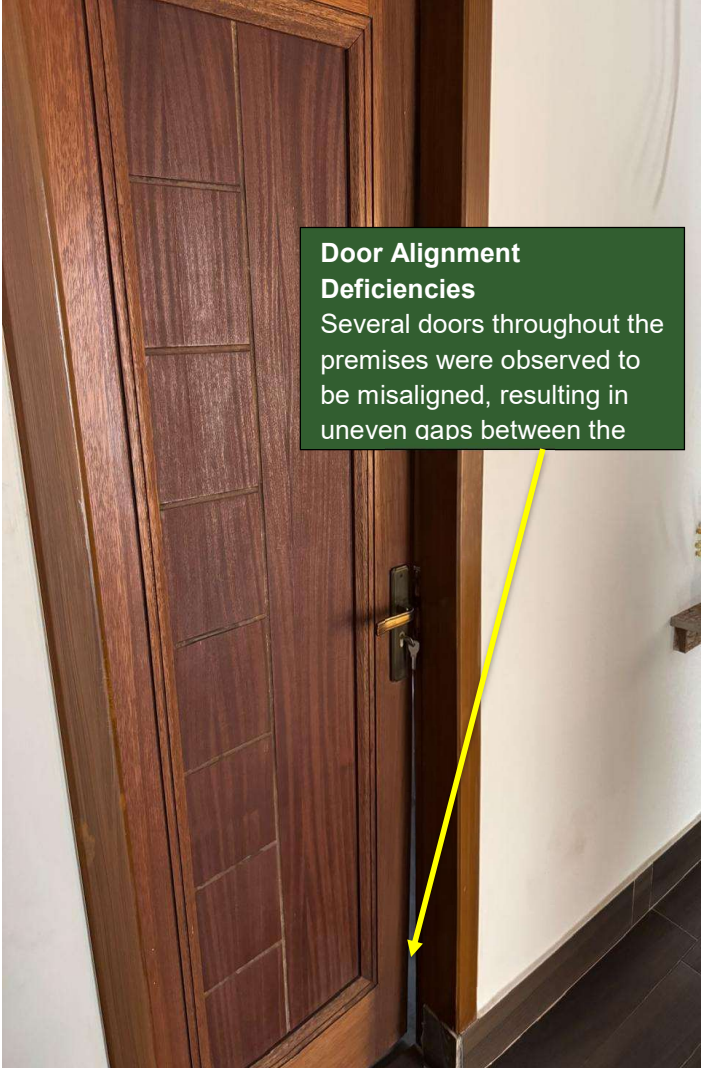
ISSUE 11 Door Alignment Deficiencies and Incomplete Hardware Installation

Several doors throughout the premises were observed to be misaligned, resulting in uneven gaps between the door leaf and frame. In addition, some doors were found without the required door locksets, leaving the joinery incomplete and affecting functionality.

| ENGINEERING ASSESSMENT<br>The observed uneven gaps are attributable to the deflection (warping) of the wooden door leaves rather than installation misalignment. The deformation has adversely affected door alignment, closing performance, and overall appearance. In addition, several doors are missing locksets, rendering them functionally incomplete. Warped timber doors cannot be permanently rectified through hinge adjustments alone; therefore, replacement of the affected door leaves is recommended to restore proper functionality, durability, and compliance with the required quality standards. | | | |

| RECOMMENDED ACTION | Replace all affected door leaves exhibiting warping or deflection with new, properly seasoned and dimensionally stable wooden doors conforming to the project specifications. Install new doors with the required hardware, including locksets where missing, and ensure correct alignment, uniform clearances, and smooth operation. | | |

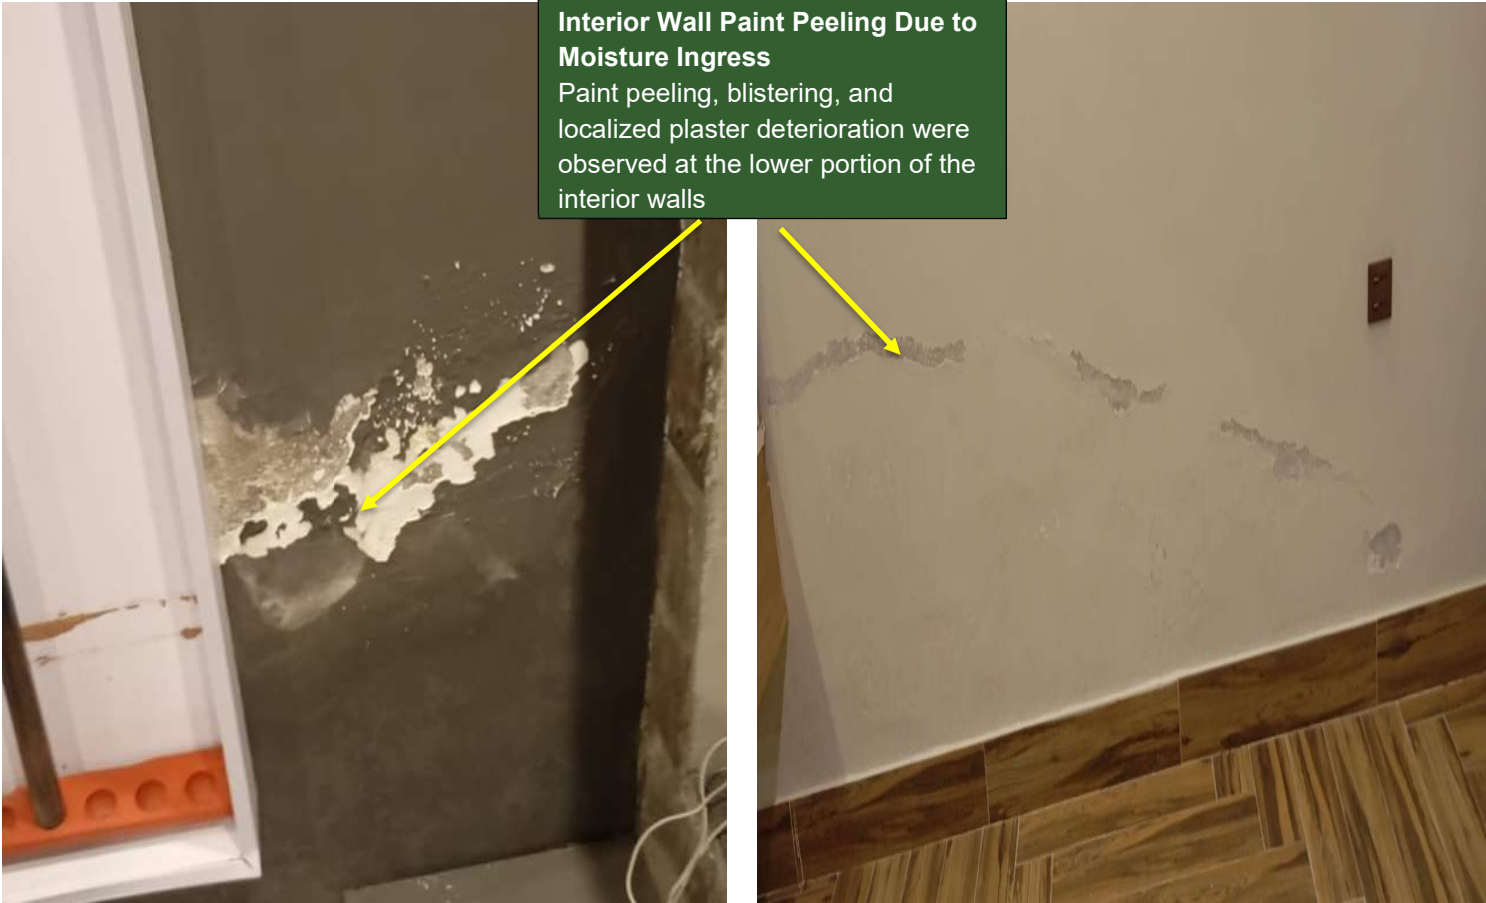
ISSUE 12 Interior Wall Paint Peeling Due to Moisture Ingress

Paint peeling, blistering, and localized plaster deterioration were observed at the lower portion of the interior walls. The pattern of damage indicates moisture ingress from the wall base, resulting in loss of adhesion of the paint and deterioration of the wall finish.

| ENGINEERING ASSESSMENT<br>The observed defect is consistent with moisture-induced deterioration of the wall finish. Prolonged moisture exposure has caused the paint coating to lose adhesion and the underlying plaster to deteriorate. If the source of moisture is not rectified, the defect will continue to propagate and may result in recurring paint failure, further plaster damage, and potential deterioration of adjacent finishes. Rectification of the moisture source followed by complete restoration of the wall finish is recommended to ensure long-term durability and serviceability. | | | |

| RECOMMENDED ACTION | Identify and rectify all sources of moisture ingress before commencing remedial works. Following complete drying of the affected areas, repair all damaged plaster where required and carry out a complete interior repainting of the building using the specified primer and paint system to ensure a uniform finish, consistent appearance, and long-term durability. | | |

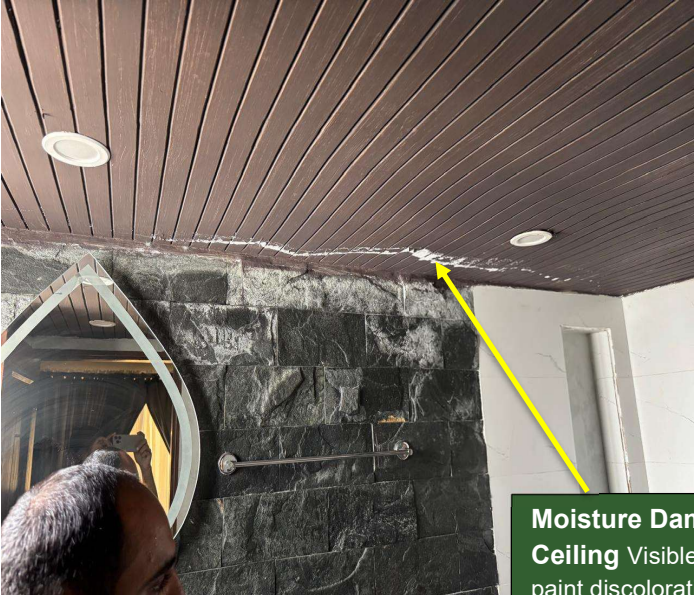
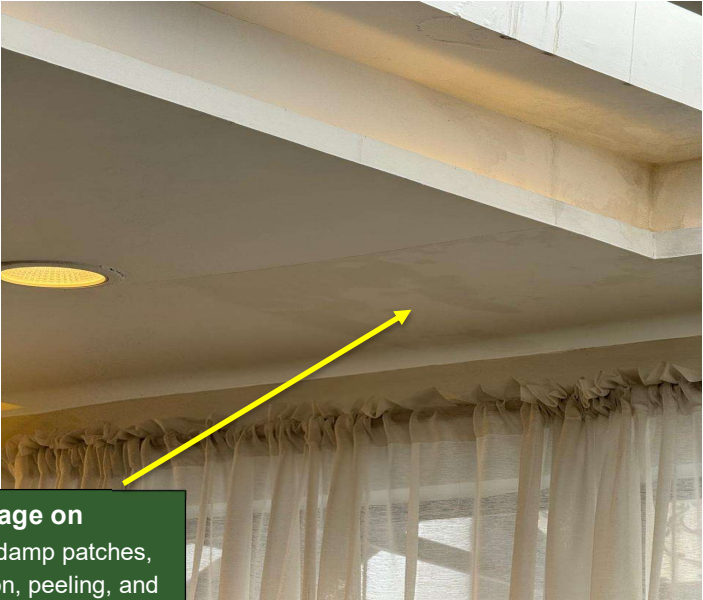
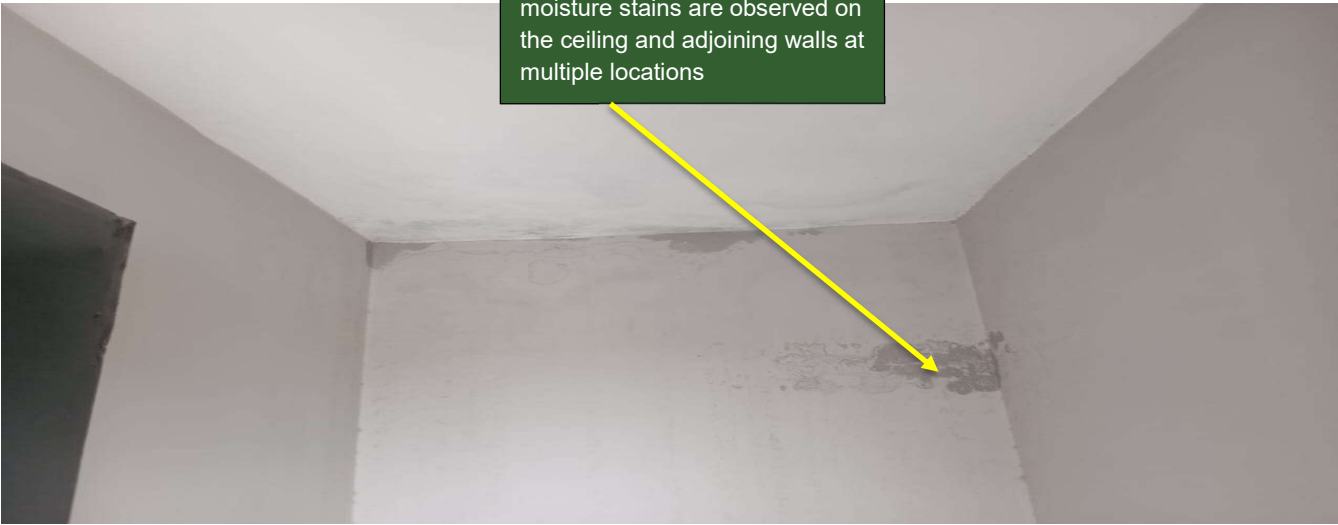
ISSUE 13    Moisture Damage on Ceiling and Walls (Roof Waterproofing Failure)

Visible damp patches, paint discoloration, peeling, and moisture stains are observed on the ceiling and adjoining walls at multiple locations. The pattern of deterioration indicates water ingress from the roof slab, suggesting that the existing roof waterproofing/insulation system is ineffective or has failed. Continued moisture penetration is causing deterioration of paint, plaster, and ceiling finishes.

Moisture Damage on Ceiling Visible damp patches, paint discoloration, peeling, and moisture stains are observed on the ceiling and adjoining walls at multiple locations

| ENGINEERING ASSESSMENT<br>The observed defects are consistent with roof waterproofing failure rather than surface-level paint defects. Moisture infiltration through the roof slab can progressively damage internal finishes, promote fungal/mold growth, corrode embedded reinforcement over time, and reduce the durability of the building envelope if left unaddressed. The issue requires investigation and rectification at the source rather than cosmetic repairs. | | | |

| RECOMMENDED ACTION | Carry out a detailed inspection of the roof to identify the source of water ingress and rectify the defective waterproofing system, including all roof joints and penetrations. After eliminating the leakage, allow the affected areas to dry completely, repair the damaged plaster and paint, and apply a fresh finish only after confirming that no further moisture intrusion is present. | | |
