# Complete Engineering Inspection Case Study

Full anonymized public edition compiled from both submitted reports

ENGINEERING EXECUTIVE SUMMARY

Overall Engineering Condition Assessment

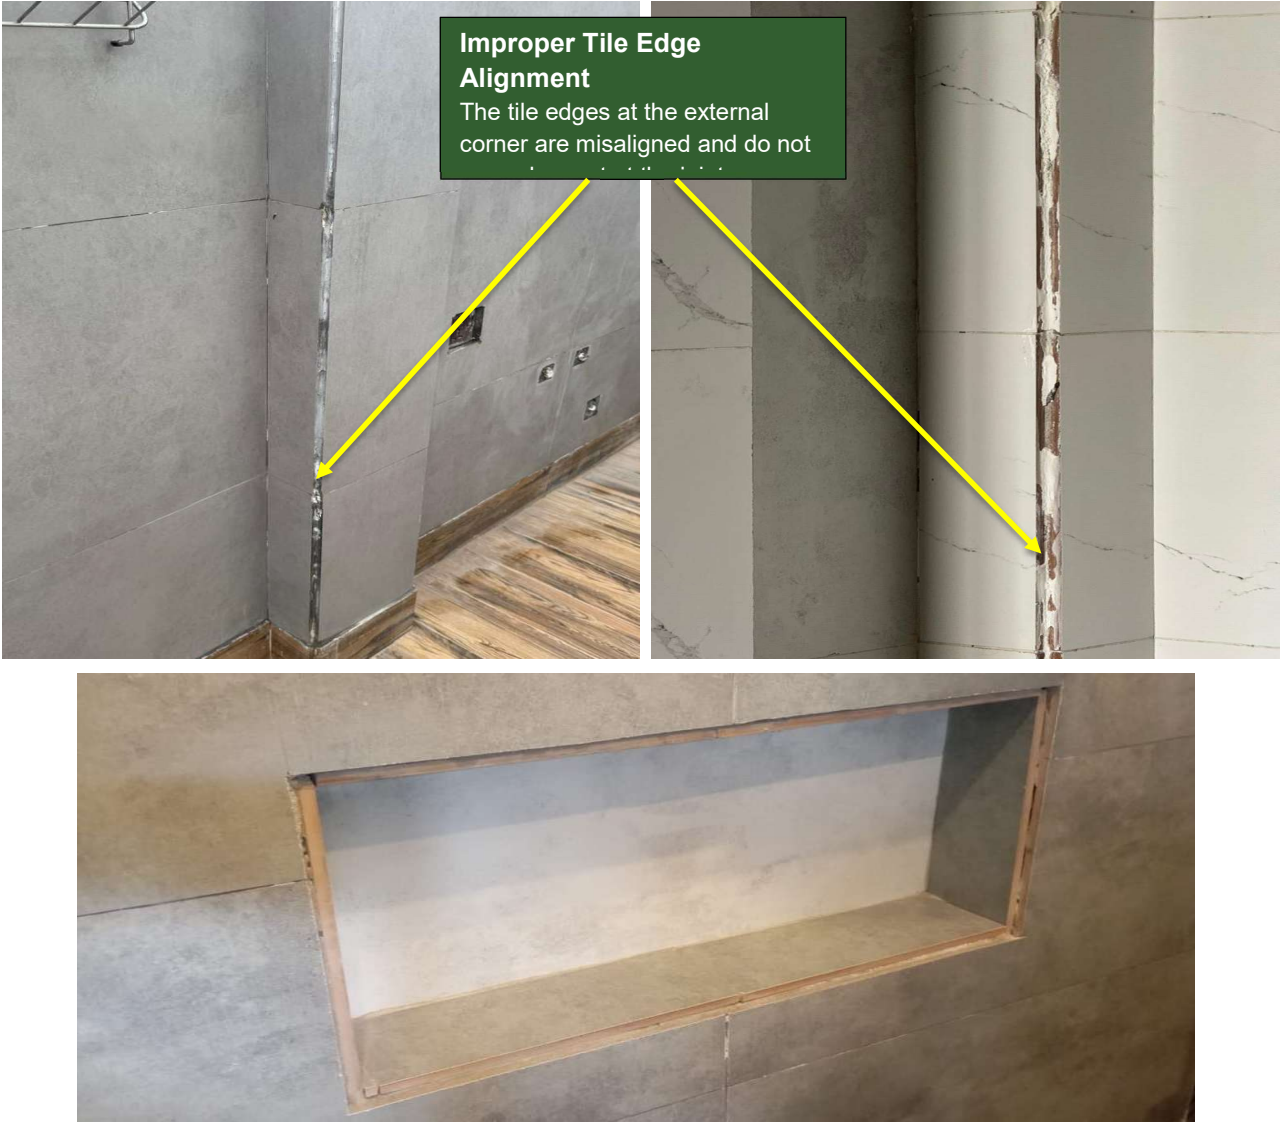
ISSUE 14 Improper Tile Edge Alignment and Joint Finishing

The tile edges at the external corner are misaligned and do not properly meet at the joint. In addition, the corner joint is inadequately filled and finished, leaving visible gaps that compromise both the appearance and water resistance of the tiled surface.

| ENGINEERING ASSESSMENT<br>The improper alignment and incomplete joint sealing indicate poor workmanship during tile installation. If left unrectified, these open joints may permit water ingress behind the tiles, leading to moisture penetration, de-bonding of tile adhesive, and long-term deterioration of the substrate. | | | |

| RECOMMENDED ACTION | Remove and reinstall the affected corner tiles to achieve proper alignment and uniform joint spacing. Fill and seal all joints with an appropriate waterproof grout or sealant to prevent water ingress and ensure a durable, aesthetically acceptable finish. | | |

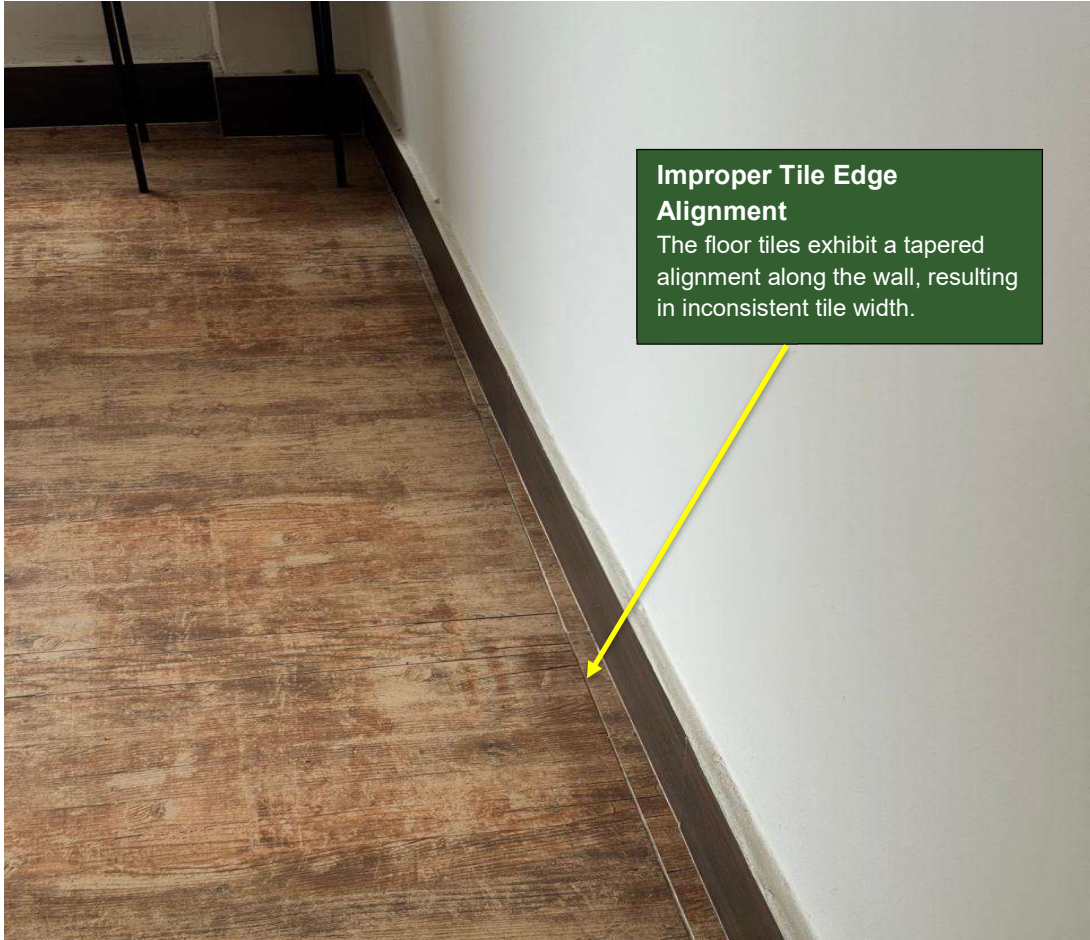
ISSUE 15Improper Tile Alignment Due to Wall Deviation

The floor tiles exhibit a tapered alignment along the wall, resulting in inconsistent tile width. This is due to the existing wall deviation, which has affected the tile layout and visual appearance.

| ENGINEERING ASSESSMENT<br>The observed taper is attributable to the existing wall alignment rather than a structural concern. While it does not impair the performance of the tiled floor, it represents a workmanship and aesthetic deficiency that detracts from the overall finish quality. | | | |

| RECOMMENDED ACTION | No rectification is recommended, as correcting the wall alignment would require extensive demolition and reconstruction. The condition may be accepted as an aesthetic defect, provided it does not affect the functionality, safety, or serviceability of the flooring. | | |

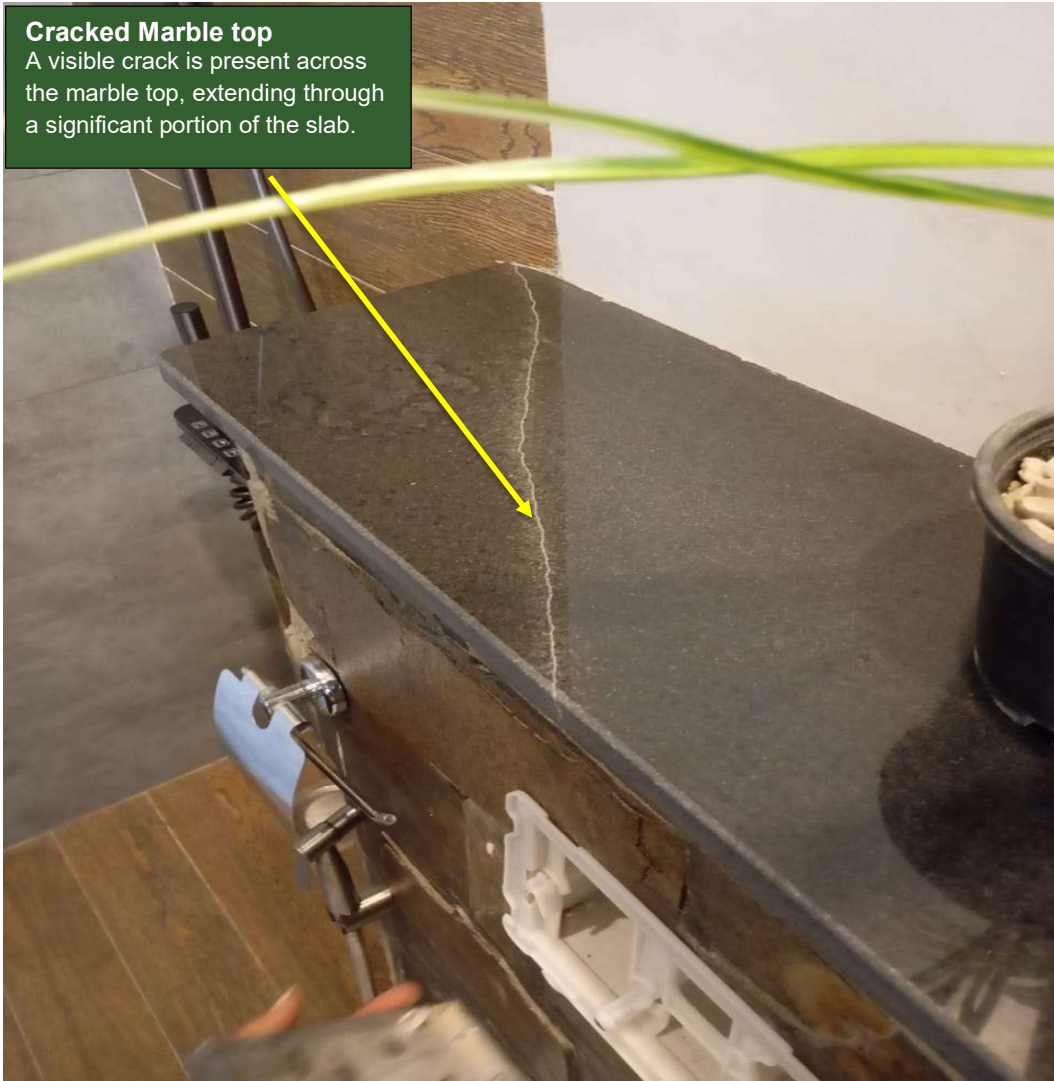
ISSUE 16Cracked Marble top

A visible crack is present across the marble top, extending through a significant portion of the slab. The defect adversely affects the aesthetic appearance and may worsen over time if subjected to loading or impact.

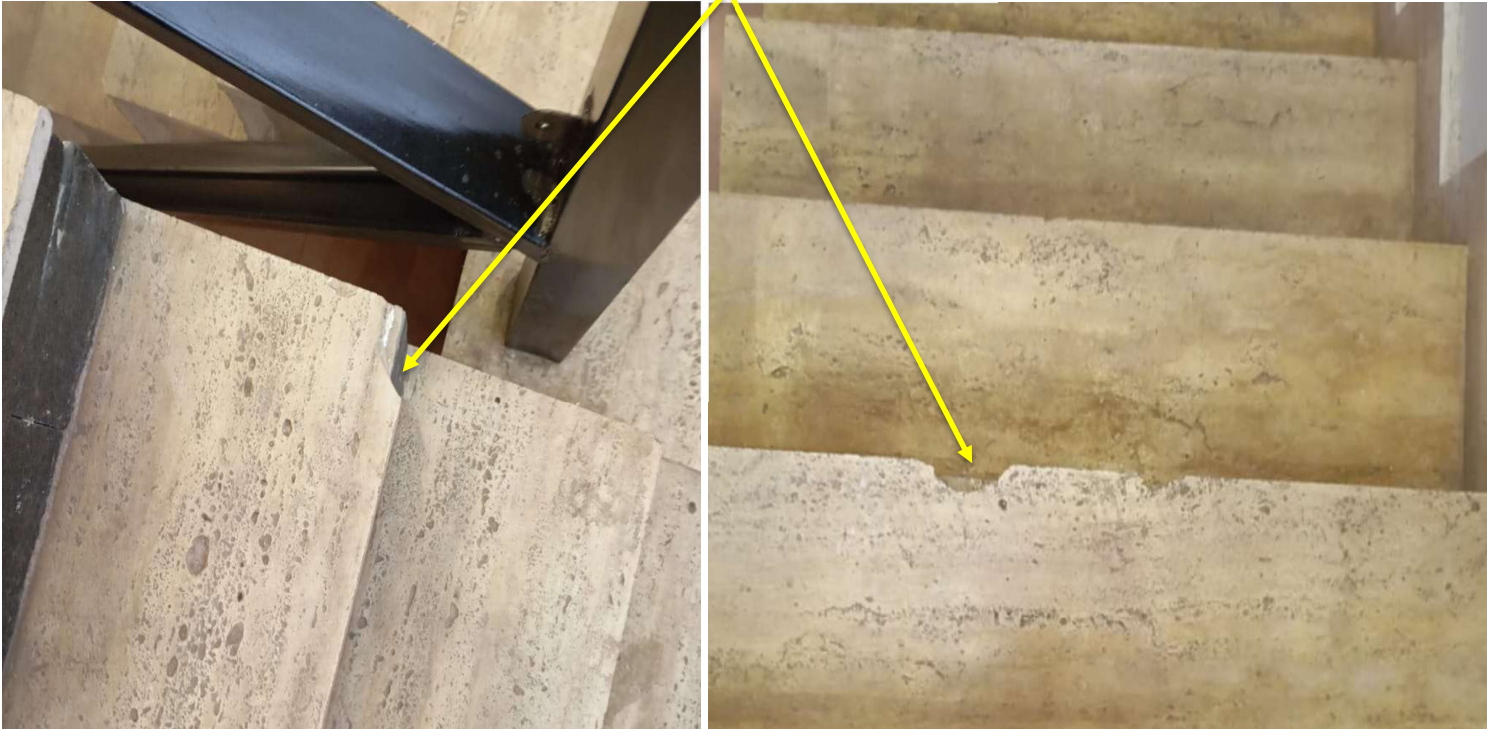
Damaged Travertine Stair Tread

The travertine stair tread has a chipped and damaged front edge (nosing)

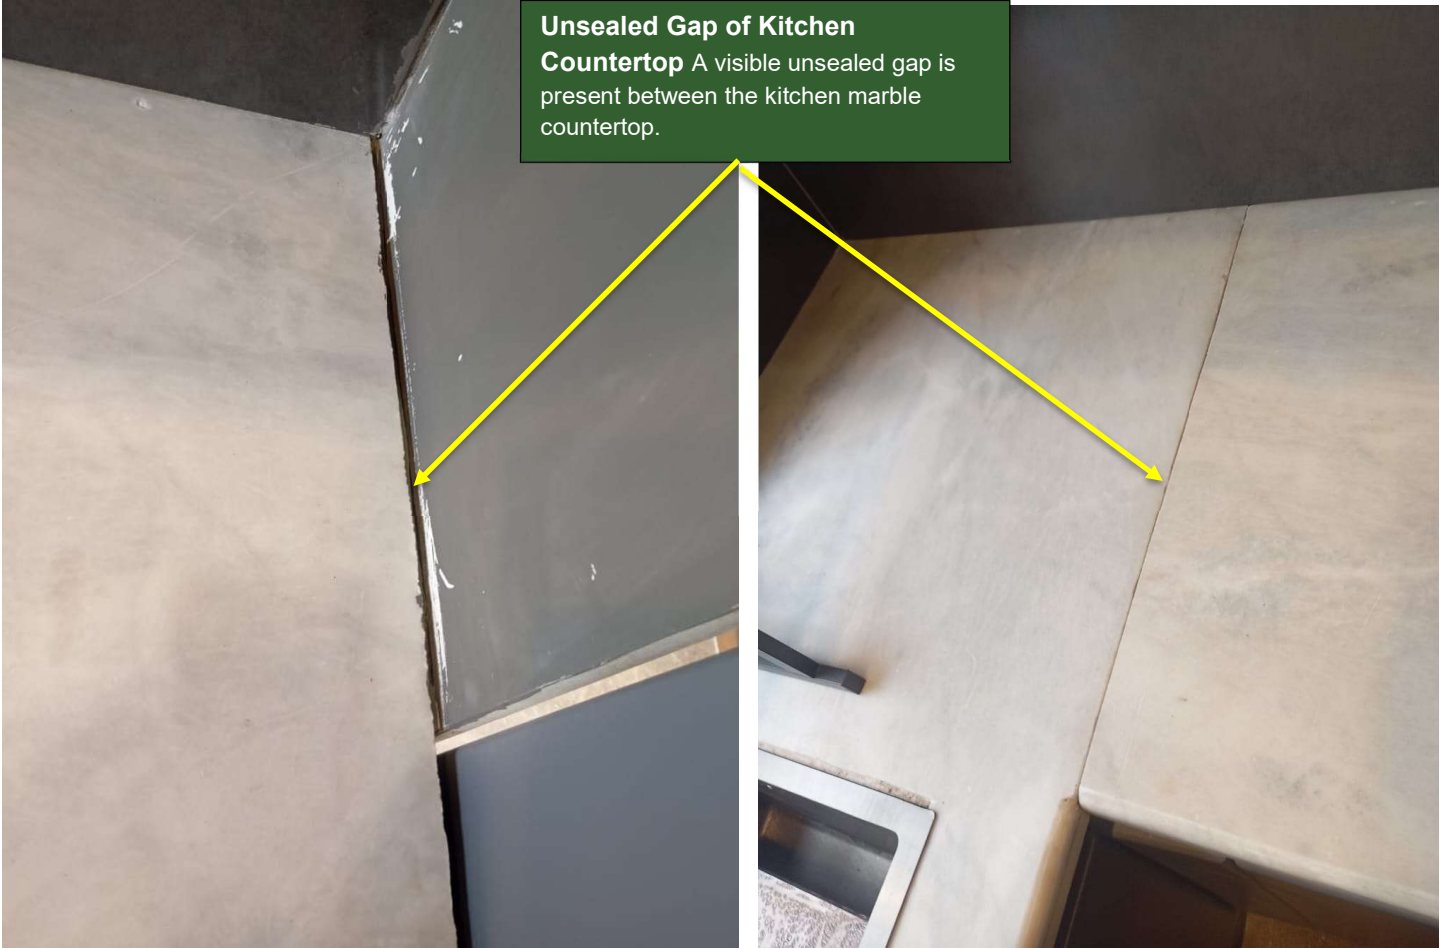
ISSUE 18    Unsealed Gap Between Kitchen Countertop and Cabinet Panel

A visible unsealed gap is present between the kitchen marble countertop and the adjacent cabinet side panel. This opening allows water and other liquids to penetrate into the cabinet, increasing the risk of moisture damage.

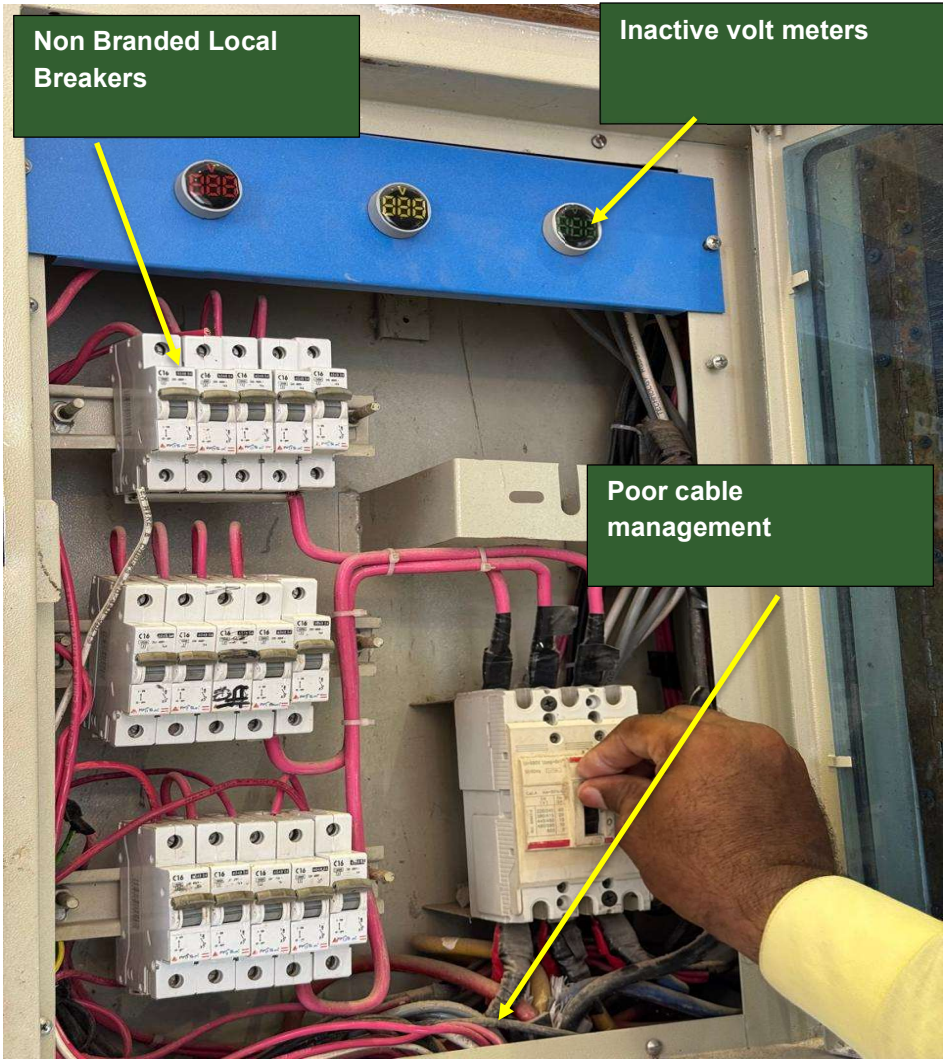
ISSUE 19    Distribution Board (DB) Wiring and Electrical Compliance Deficiencies

The distribution board exhibits multiple deficiencies, including poor cable management, absence of visible cable manufacturer identification, installation of local/non-approved circuit breakers, and a first-floor main MCCB that was found to be defective and not functioning properly during inspection.

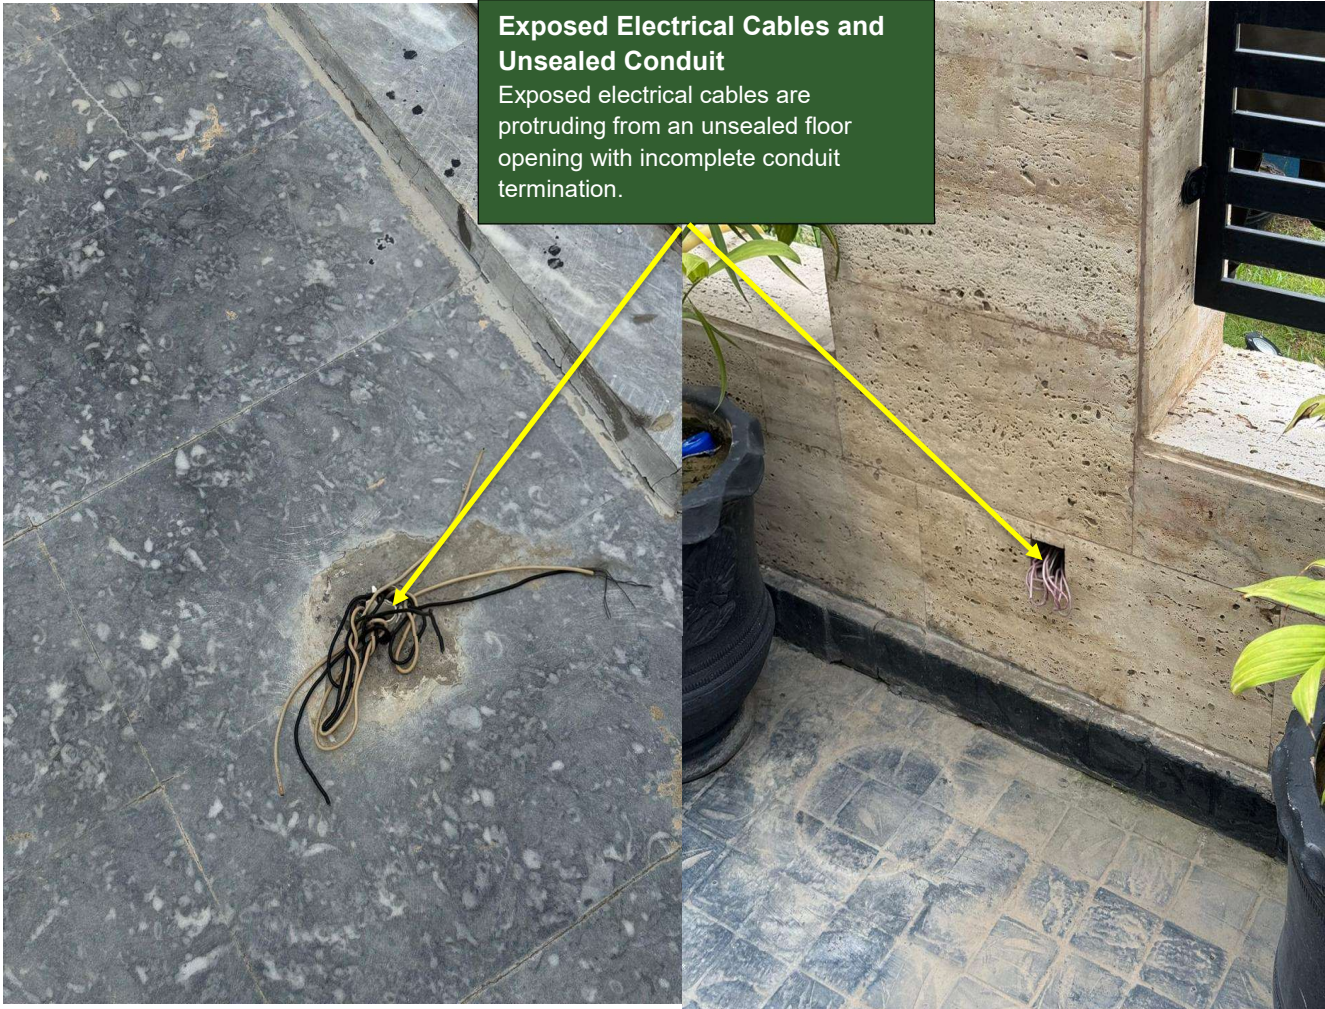
ISSUE 20 Exposed Electrical Cables and Unsealed Conduit on Roof

Exposed electrical cables are protruding from an unsealed floor opening with incomplete conduit termination. The installation allows rainwater to enter the conduit system and leaves the cables susceptible to mechanical damage and environmental exposure.

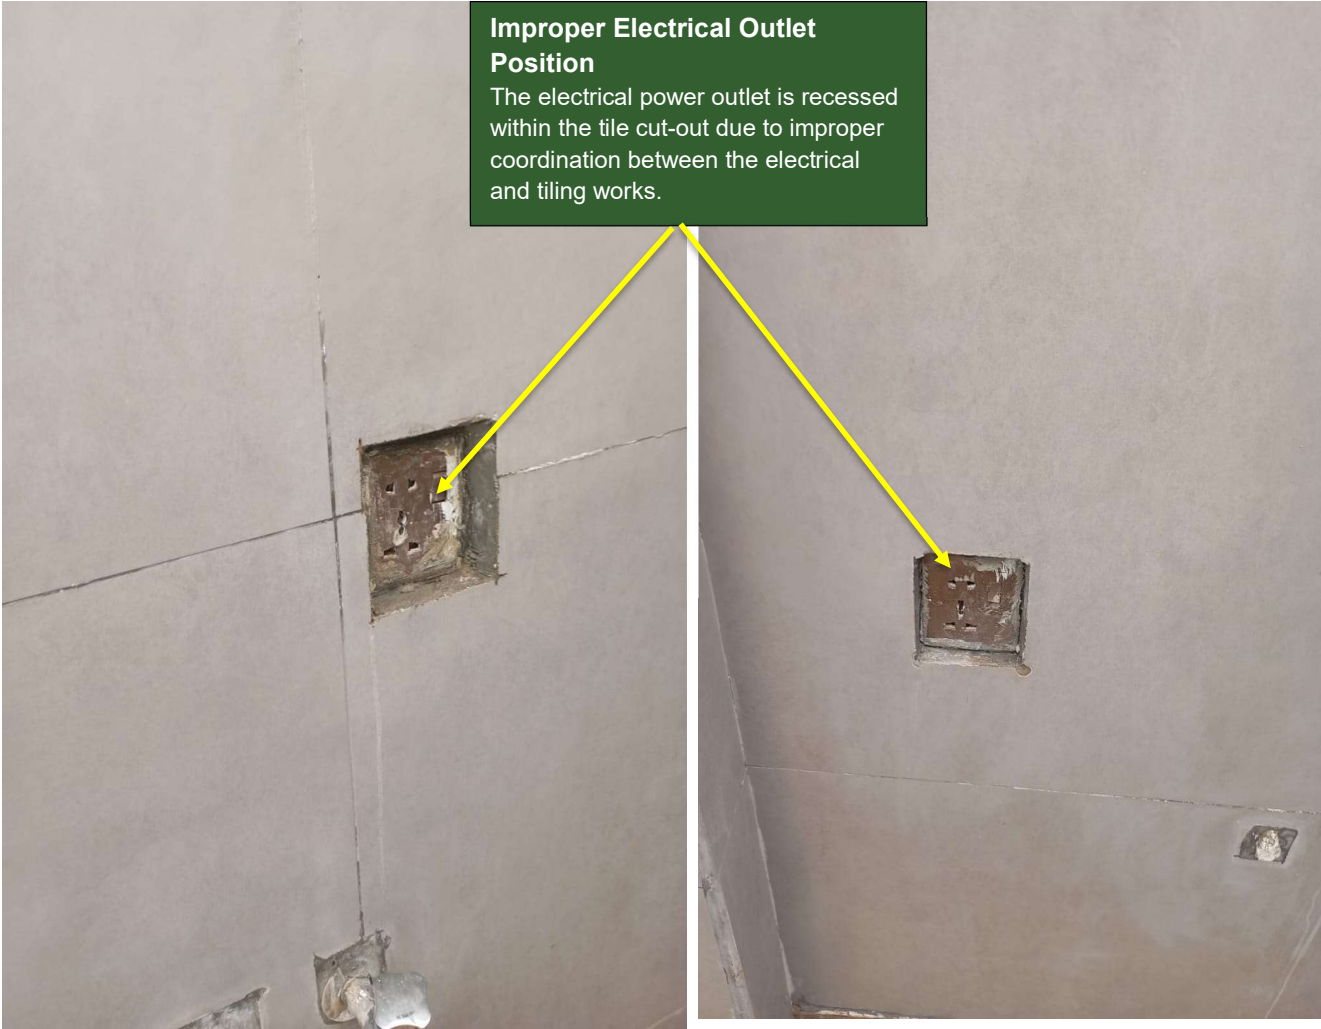
ISSUE 21    Improper Electrical Outlet Position After Tile Installation

The electrical power outlet is recessed within the tile cut-out due to improper coordination between the electrical and tiling works. The outlet face is not flush with the finished tile surface, resulting in an incomplete and poor-quality installation.

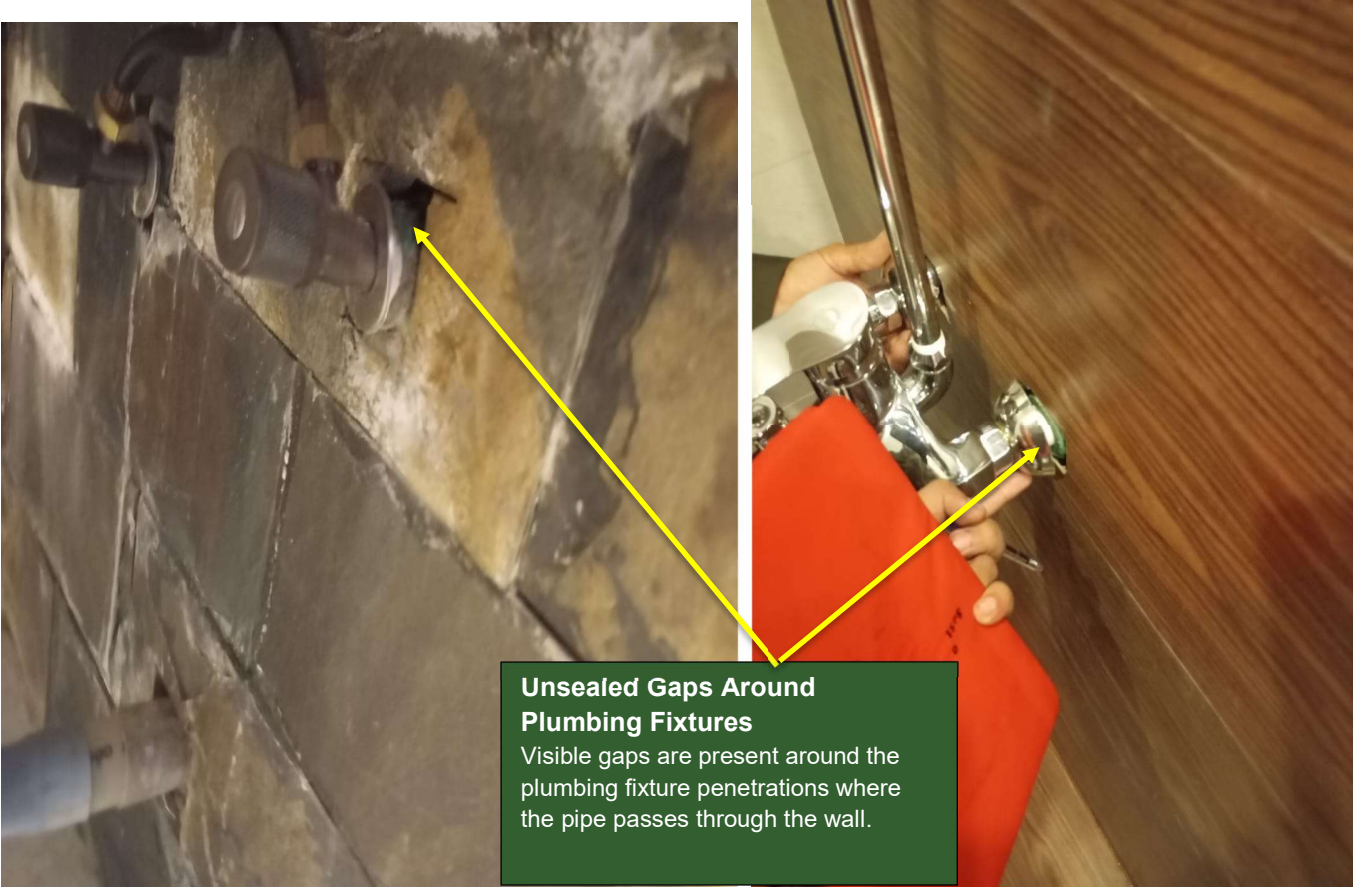
ISSUE 22    Unsealed Gaps Around Plumbing Fixtures

Visible gaps are present around the plumbing fixture penetrations where the pipe passes through the wall. The escutcheon does not fully cover the opening, leaving the wall penetration exposed. This condition was observed in multiple bathrooms.

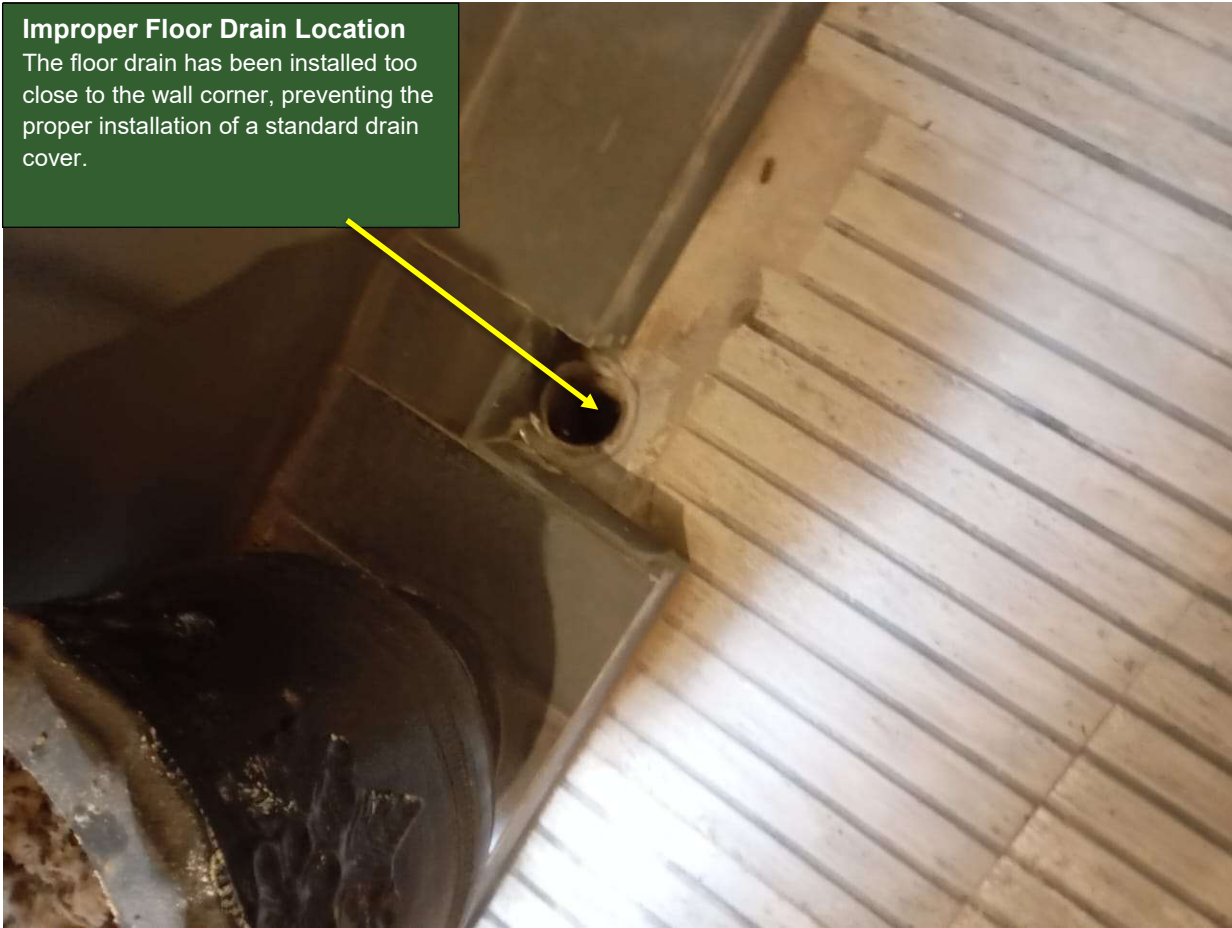
Improper Floor Drain Location

The floor drain has been installed too close to the wall corner, preventing the proper installation of a standard drain cover.

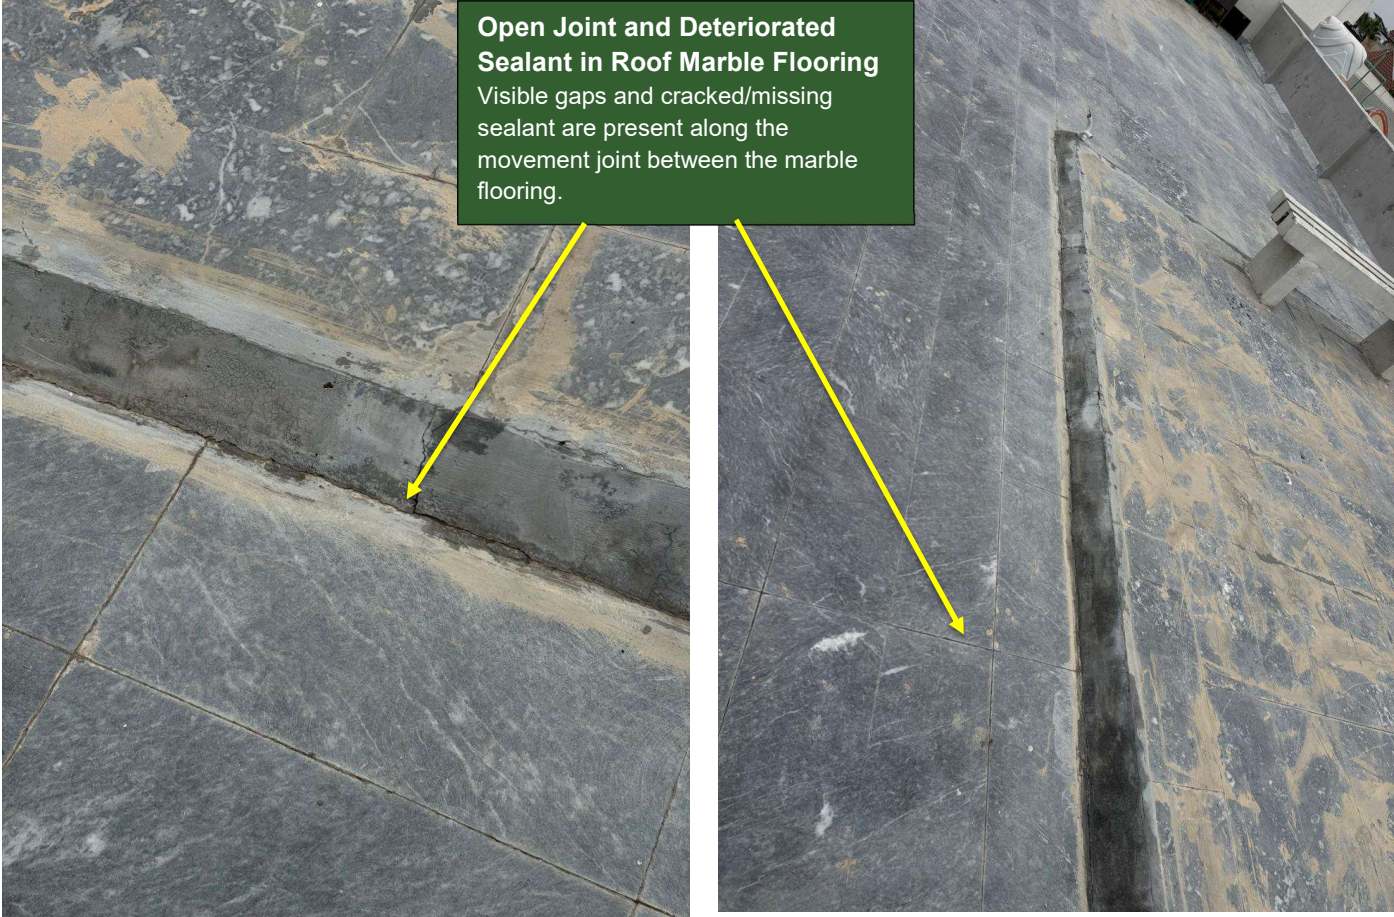
ISSUE 24 Open Joint and Deteriorated Sealant in Roof Marble Flooring

Visible gaps and cracked/missing sealant are present along the movement joint between the marble flooring. The joint is no longer watertight, creating a potential path for water ingress into the underlying floor system.

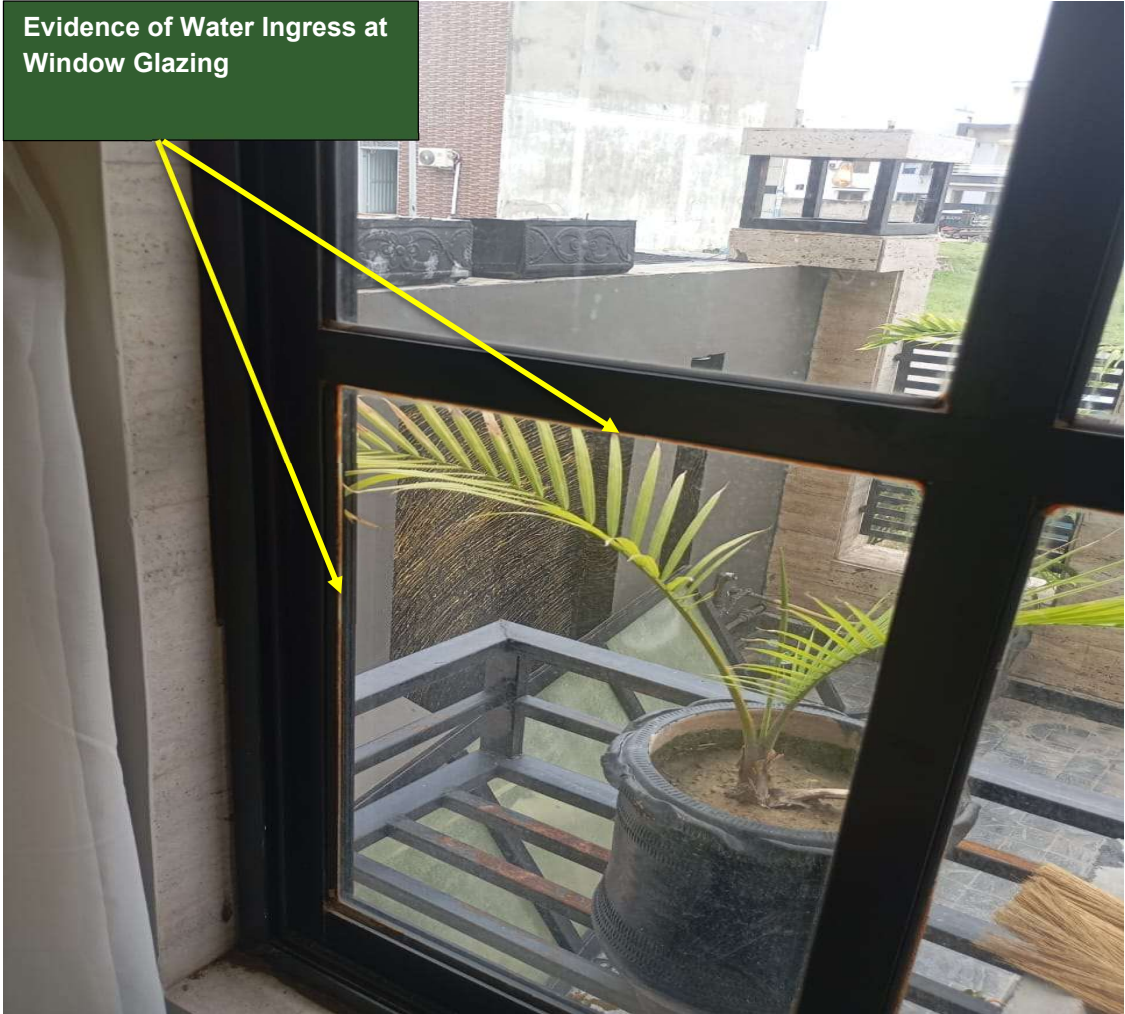
Brown/rust-colored staining is visible along the edge of the window glass adjacent to the frame, indicating moisture penetration through the glazing or perimeter seal. The condition suggests deterioration of the window sealing system.

No manufacturer name, brand label, or identification marking was found on the installed aluminium window system during the site inspection.
